Historic Properties Reuse Study of the Annandale Public School Annandale, MN

John Lauber and Company LLC Claybaugh Preservation Architecture Inc

October 2013

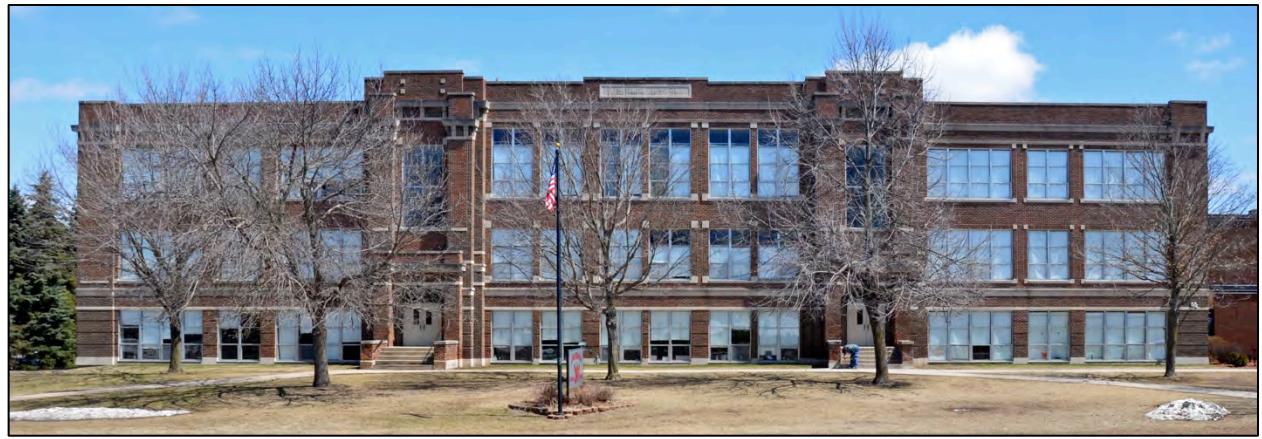
Photo 2. The principal façade of the 1922 building. The original wood double-hung windows have been replaced with single-glazed aluminum units.

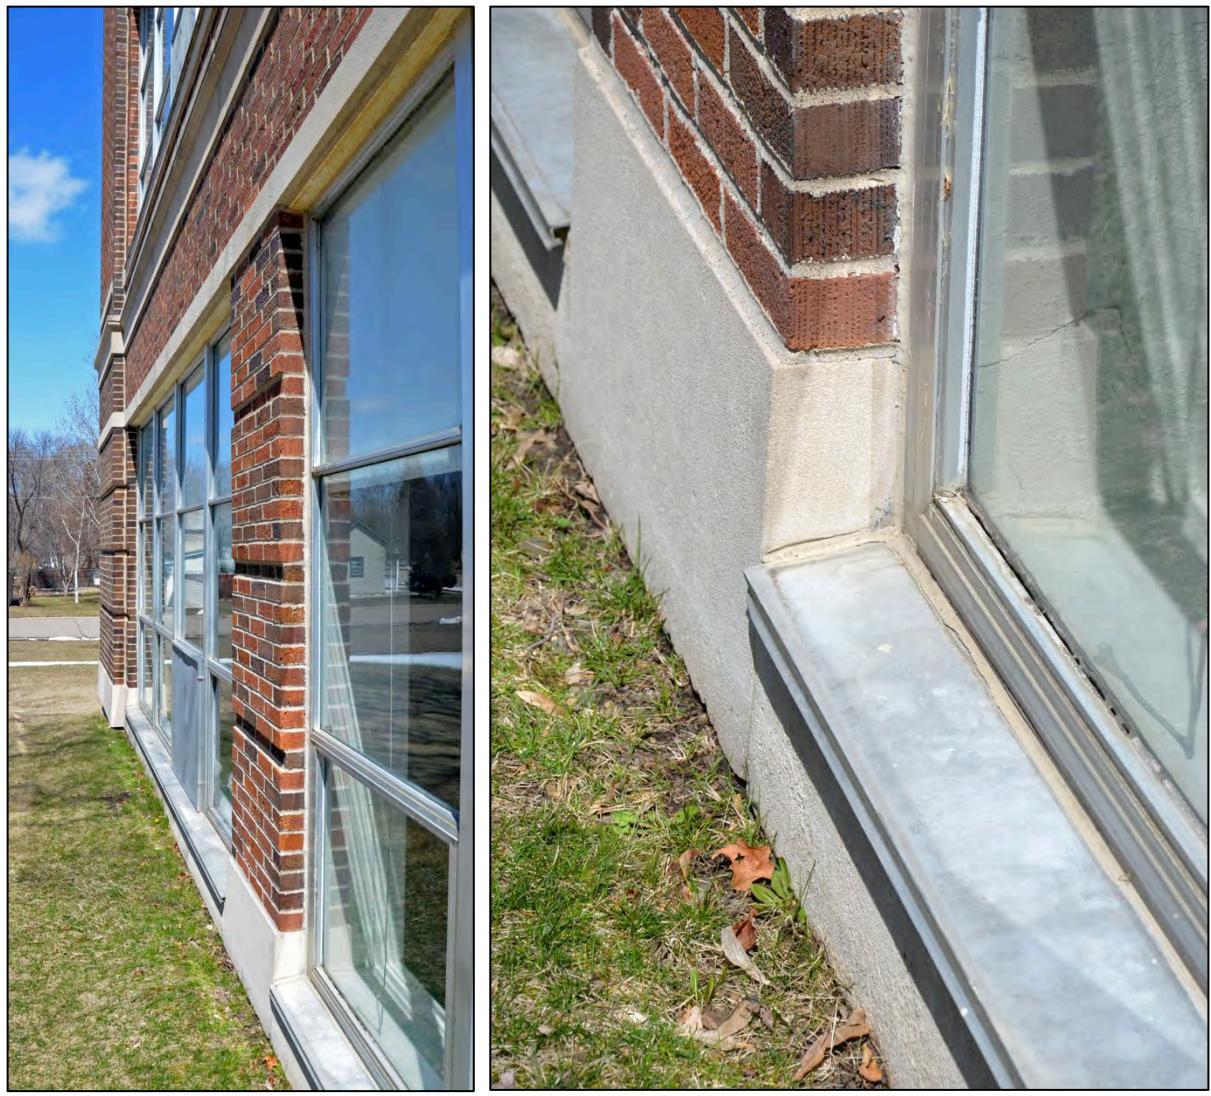
Photos 9-10. Details of the windows on the lower level (left). Limestone sills have been sheathed with aluminum.

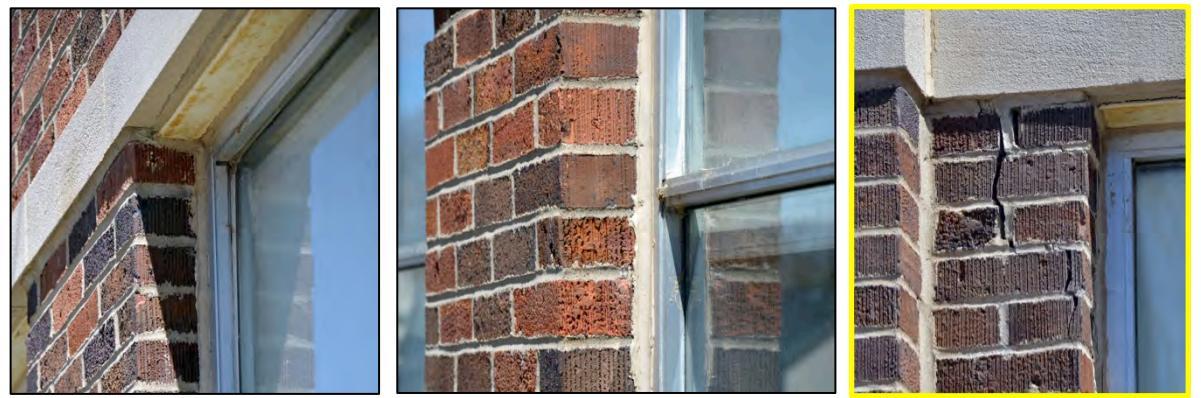
Photos 11-13. Window openings have steel lintels (left). Detail of aluminum muntin, (center). There is a small stress crack at the upper corner of the window opening at the north end of the lower level. (See photo 8 for area of detail.)

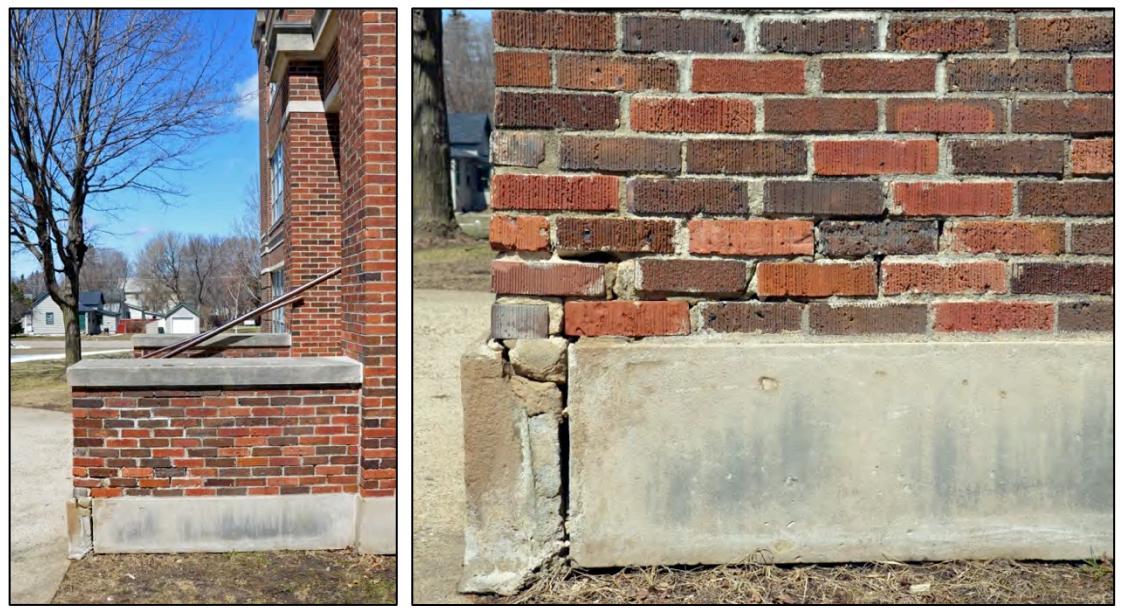
Photos 16-17. Steps at both the north and south entrances show signs of significant settlement and will need to be rebuilt. Side view of north steps (left). Detail, showing broken and loose stone at base, eroded mortar joints, and damaged brick (right).

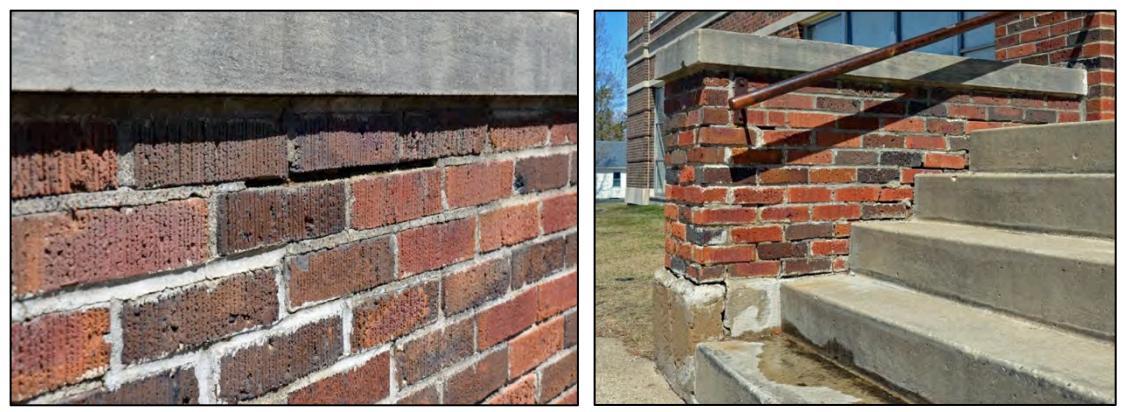
Photos 18-19. Loose and eroded mortar beneath the cap (left). Some joints have been repointed in an effort to repair the damage. The bulkhead adjacent to the steps is in poor condition (right).

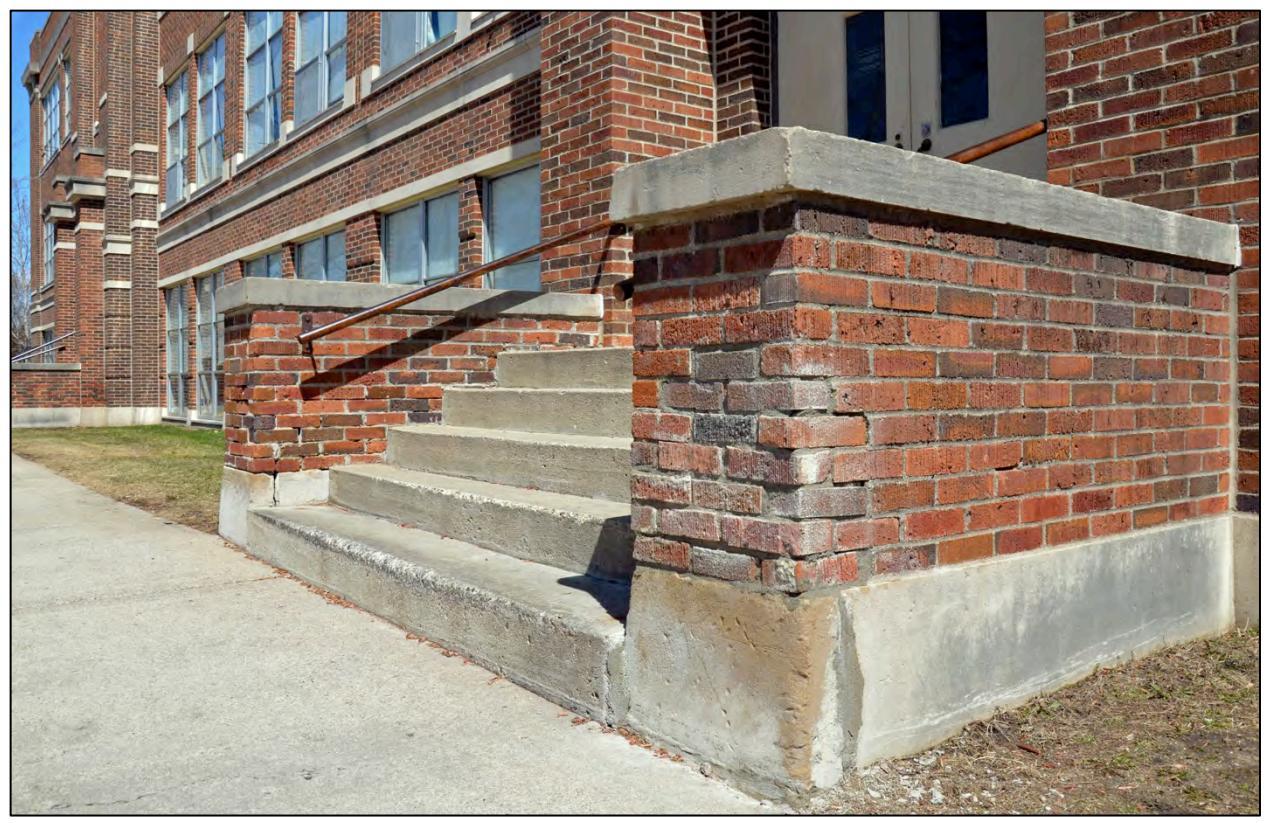
Photo 20. The south steps are also in poor condition.

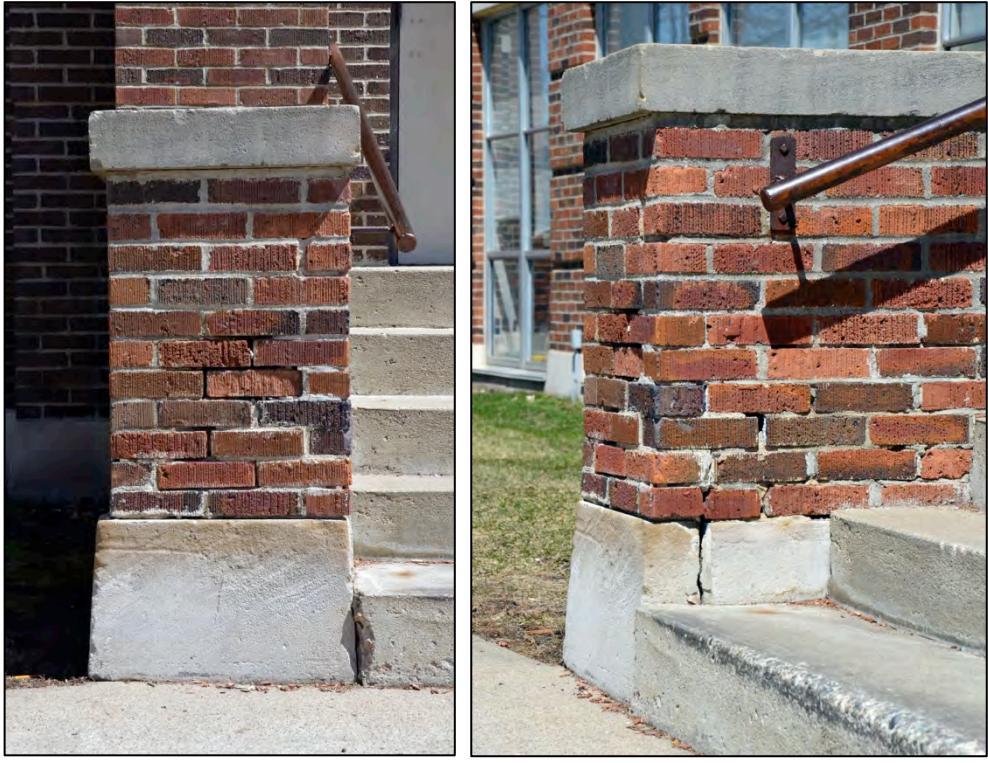
Photos 21-22. Detail of bulkhead on south steps showing missing mortar, attempts to repair joints, and damage to brick and stone.

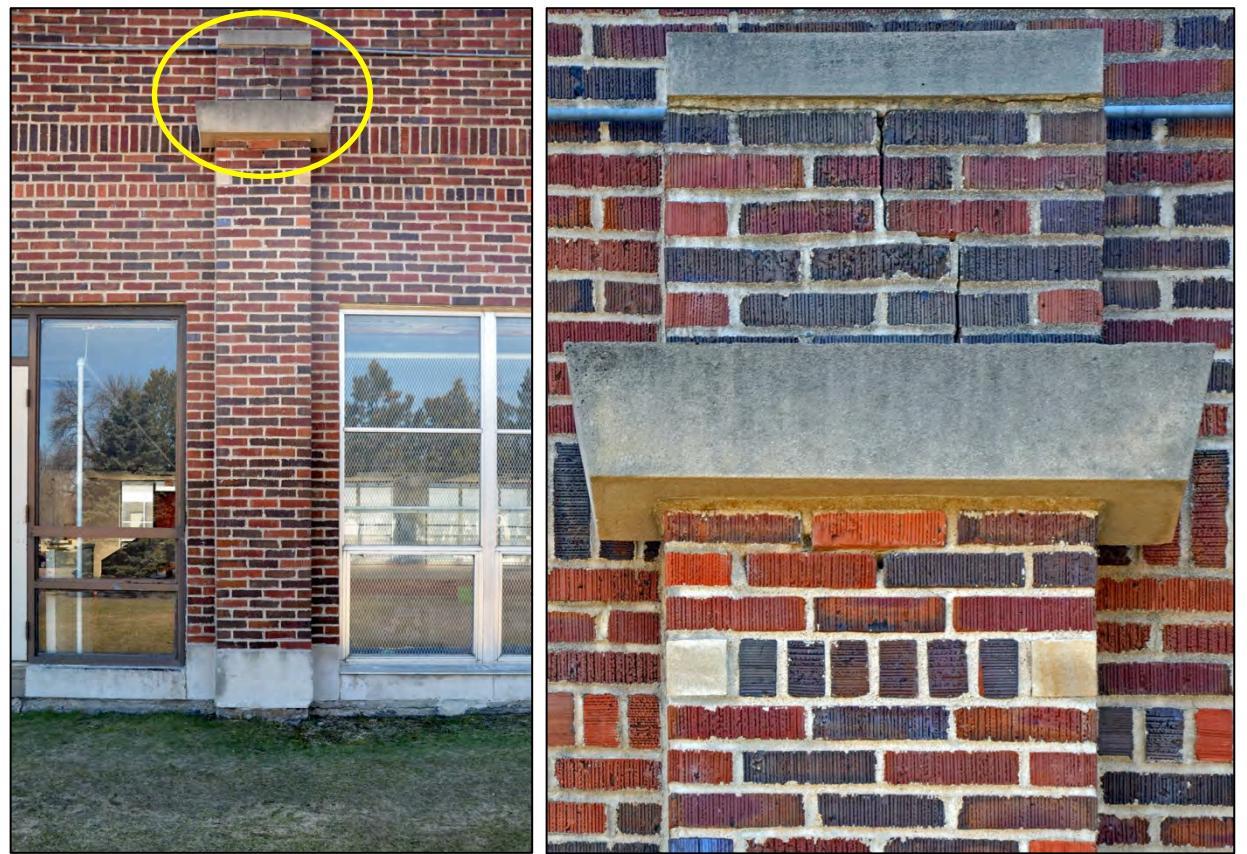
Photos 27-28. Windows in the gymnasium wing are separated by brick pilasters (left). Detail of pilaster cap, showing minor cracking. The upper walls of this wing exhibit dark stains, suggesting possible water infiltration through the parapets.

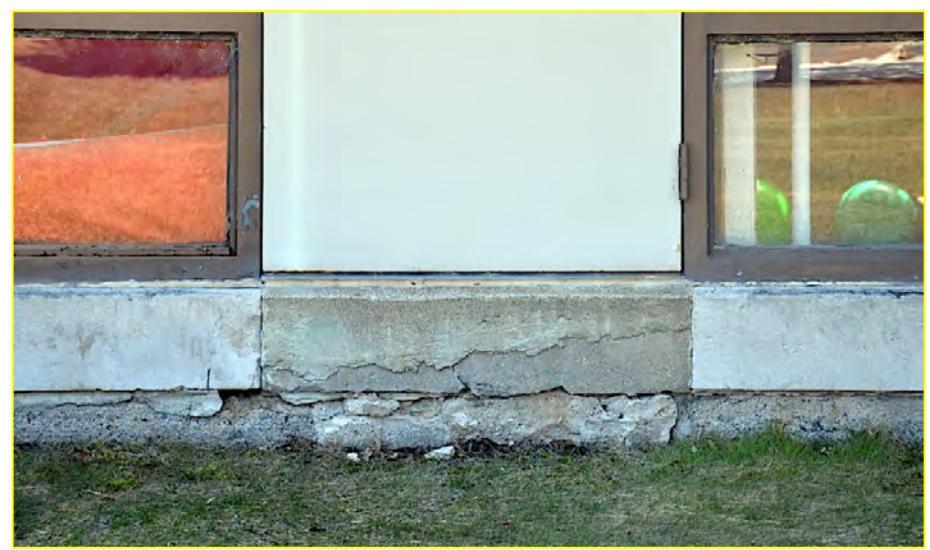
Photo 30. Detail of foundation damage beneath doorway at east end of the gymnasium wing.

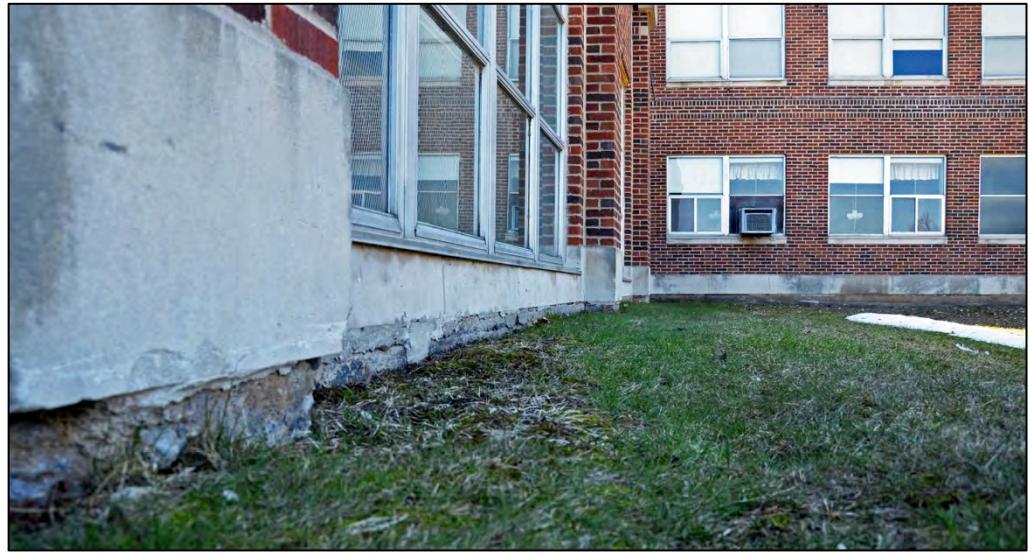
Photo 31. Negative drainage at the base of the gymnasium wing has caused significant damage to the foundation walls. Foundation walls elsewhere in the building are intact.

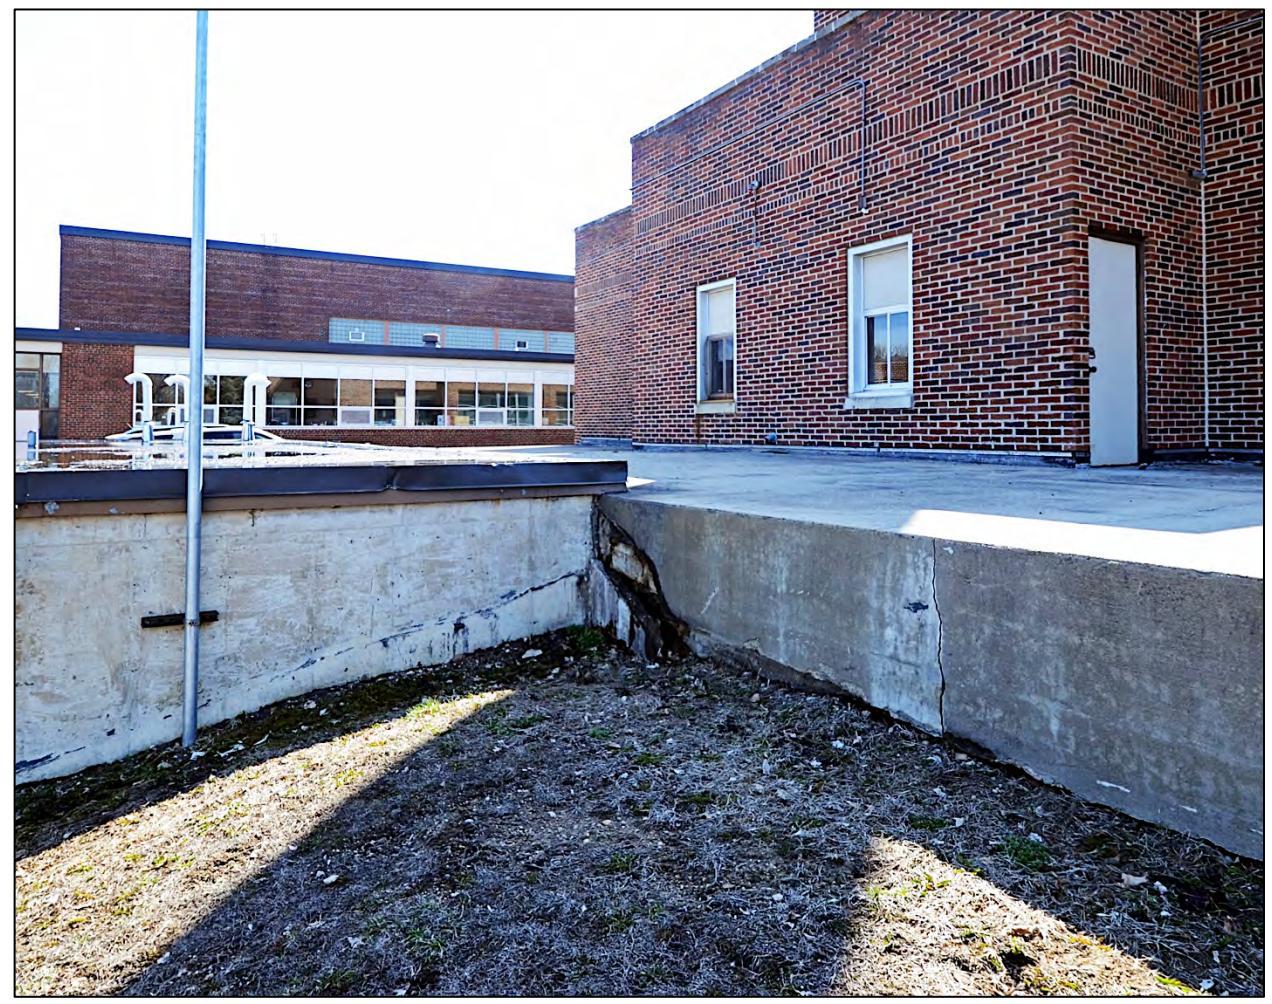
Photo 33. Detail of boiler room extension, showing damage to foundation wall.

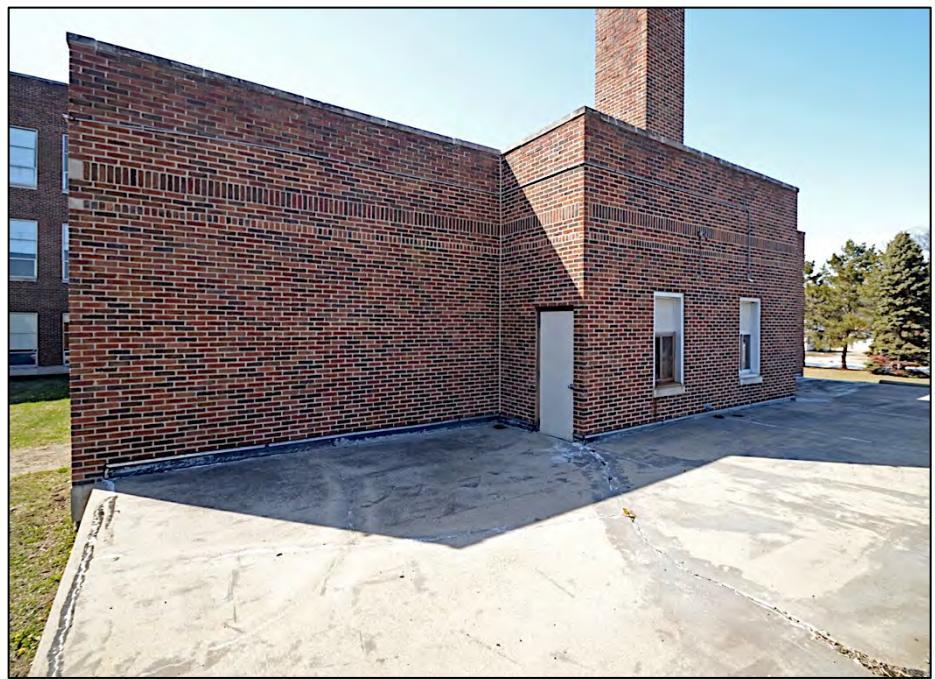
Photo 34. A large crack runs across the slab above the boiler room extension. The slab covers the original coal room. There is some evidence of water infiltration in the area directly beneath the slab.

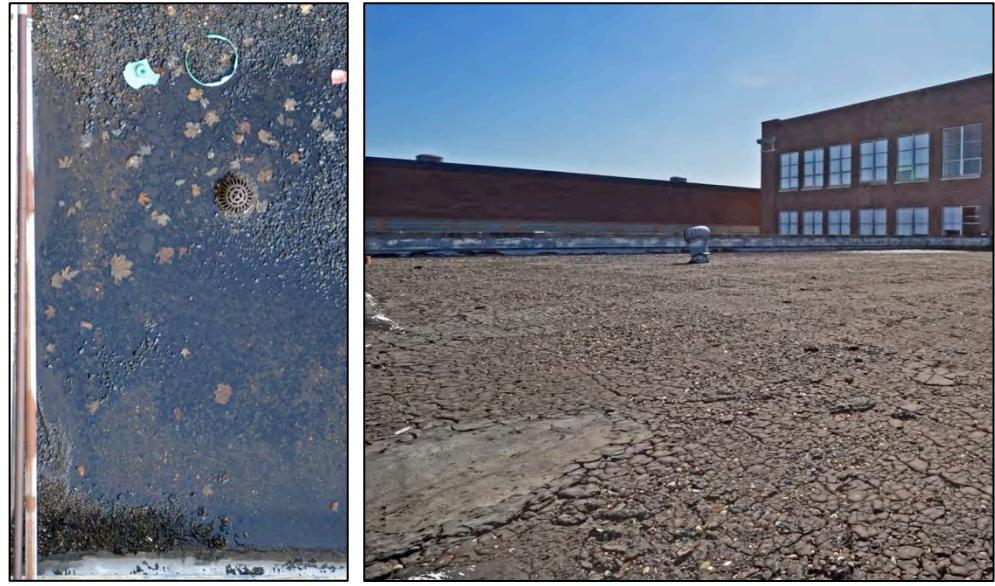
Photos 38-39. Standing water adjacent to drain in southwest corner of the gym roof. The pitch and gravel roof surface is in poor condition.

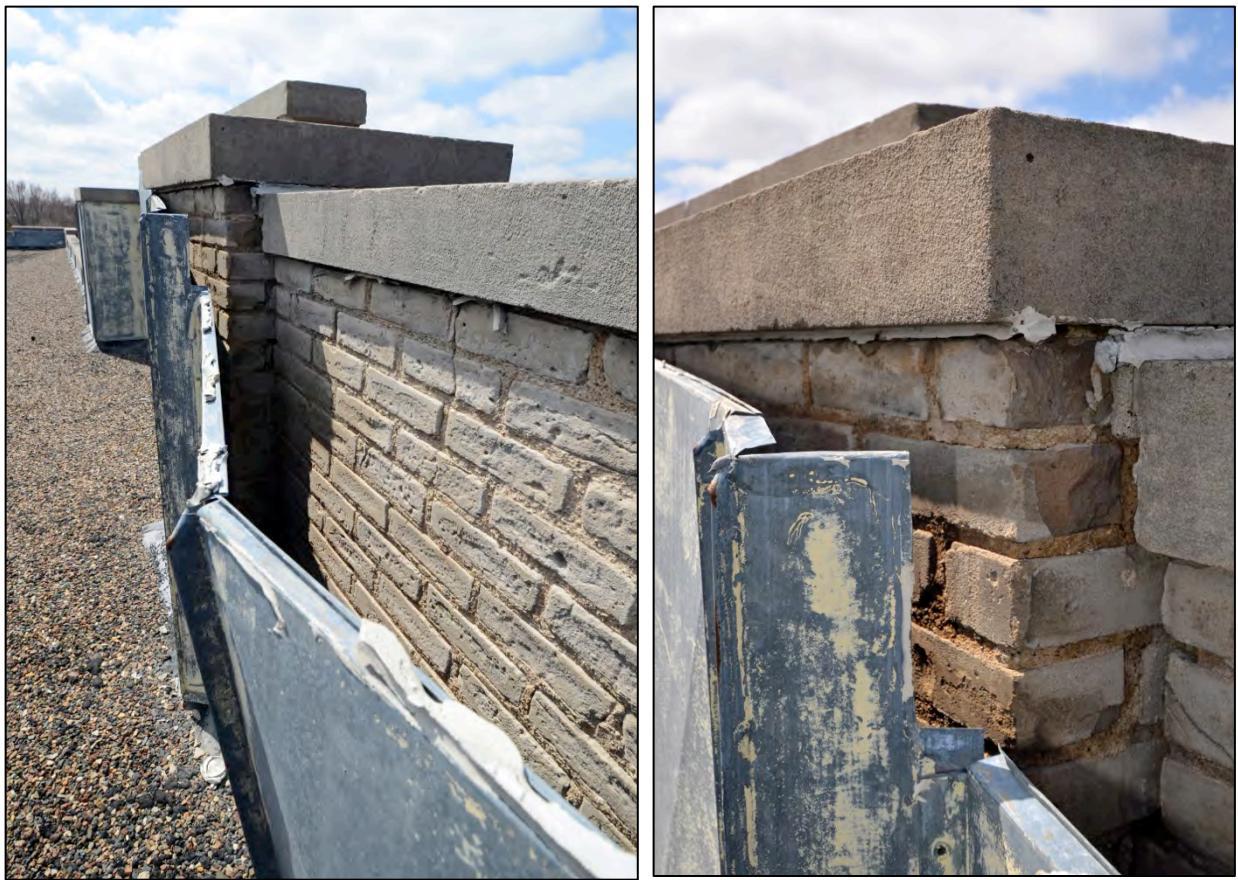
Photos 47-48. Sheet metal counter flashing has pulled loose in some areas, exposing the soft common brick that was used on the backsides of the parapets (left). Barbed flanges atop sheet metal panels were inserted beneath the coping stones (right).

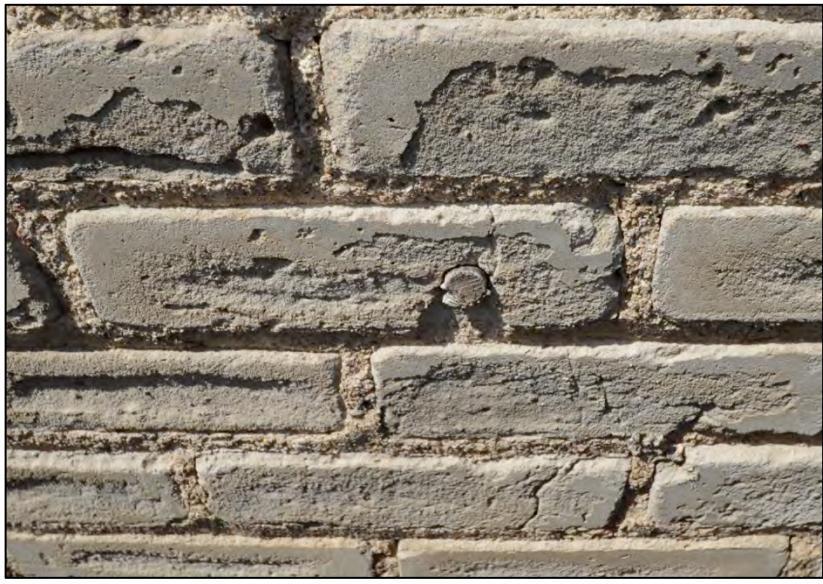
Photo 49. Detail of soft common brick used on the backsides of the parapets. Brick has been damaged by exposure to elements. Wooden plugs set into the wall served as anchors for the sheet metal counter flashing.

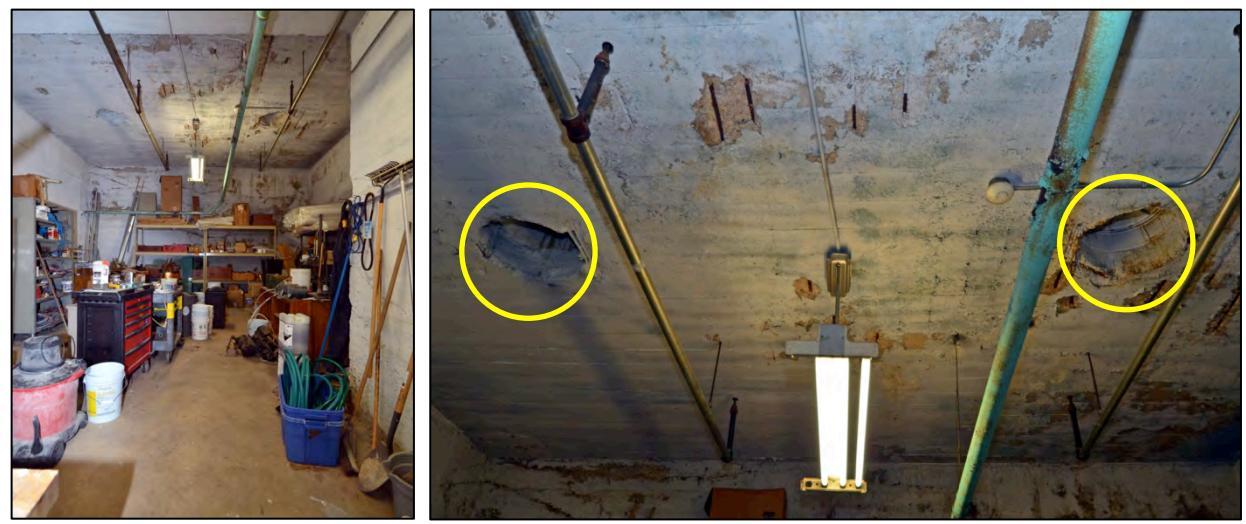
Photos 50-51. The original coal room is now used as a shop/storage space (left). Coal was loaded through hatches in the ceiling (circled, right). Spalled concrete and exposed reinforcing bars were caused by water infiltration. The coal room roof has been covered with a concrete slab.

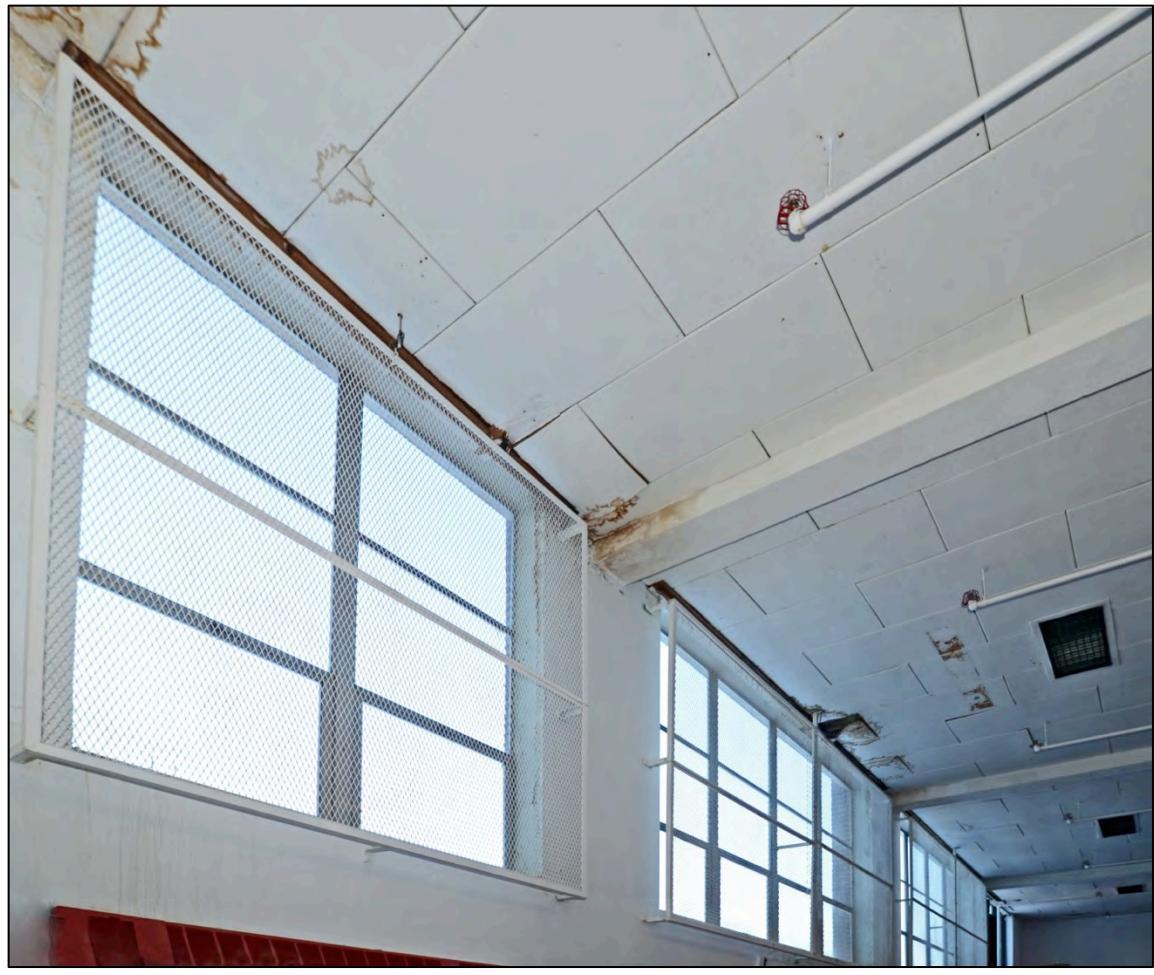
Photo 57. The ceiling above the north windows shows evidence of water infiltration.

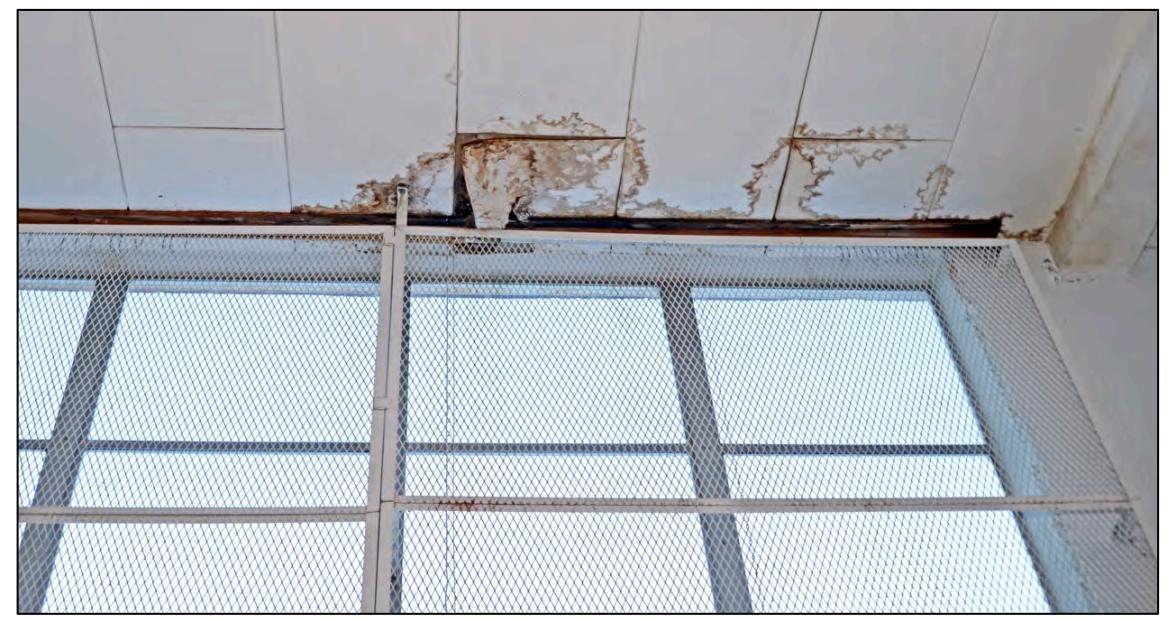
Photo 58. Detail of water-damaged ceiling tiles above the north windows.

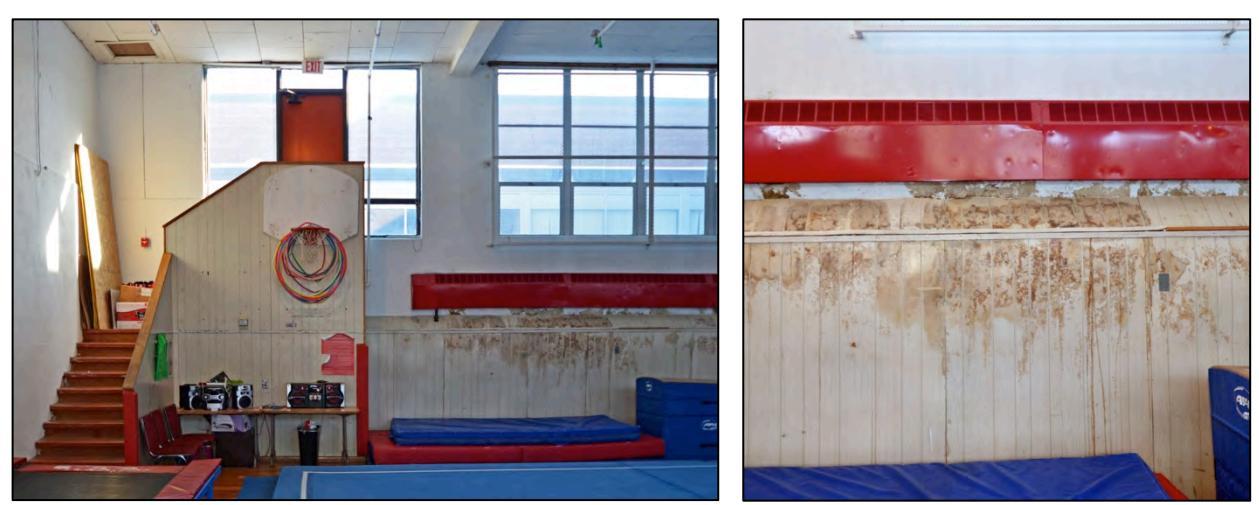
Photos 60-61. Exit stairs and windows at the southwest corner of the gymnasium (left). Window sills are essentially at grade. There is evidence of significant water infiltration through the walls just beneath the sills (right).

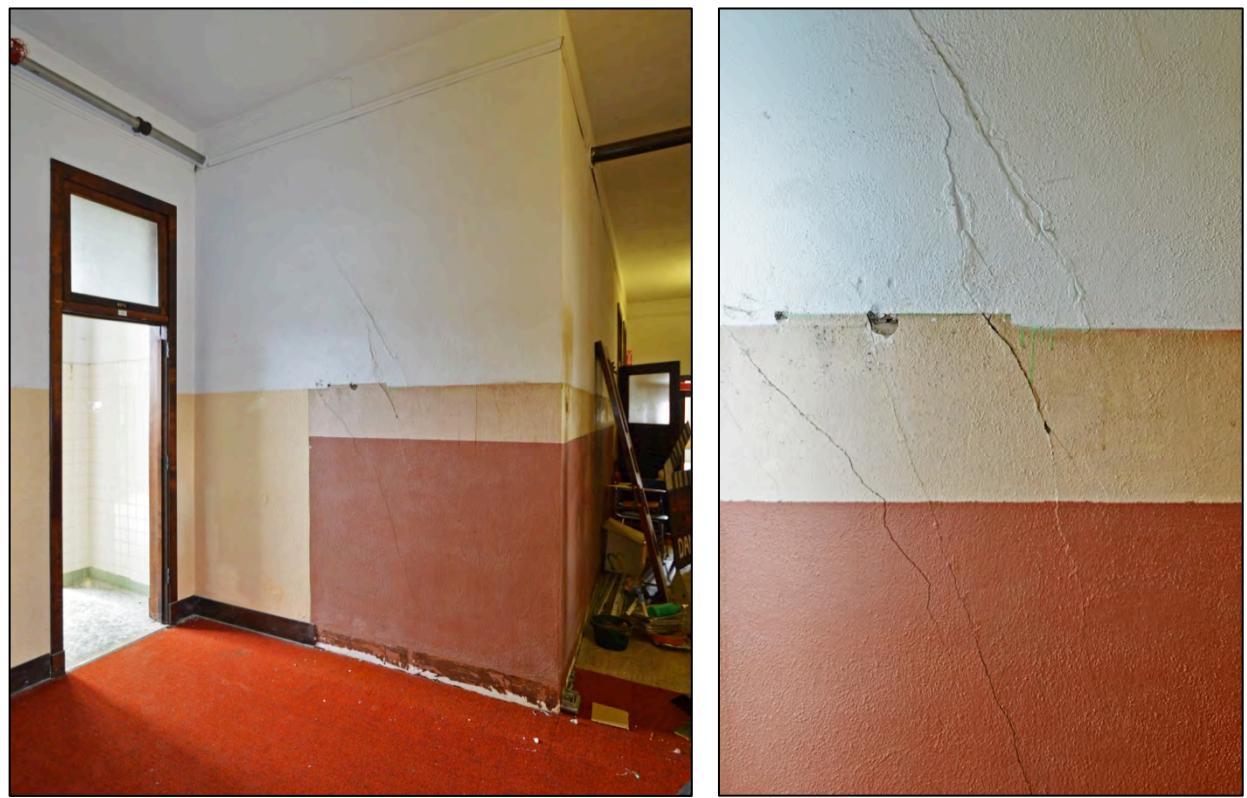
Photos 93-94. The transverse wall outside the boys' restroom on the second floor (left) exhibits minor shear cracks (detail at right). There is no evidence of active movement in this area.

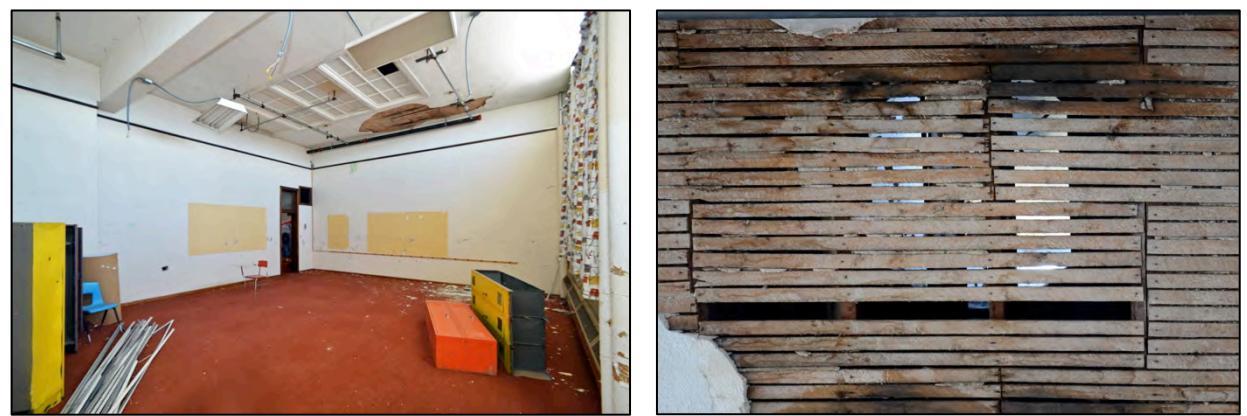
Photos 96-97. Room 304, looking southeast (left). Ceiling damage is directly beneath one of the large rooftop ventilators, and it is possible to see daylight through the lath (right), suggesting that the damage may have been caused by windblown rain infiltrating the roof through the vent.

-Cover leaking roof ventilator(s) to stop water infiltration

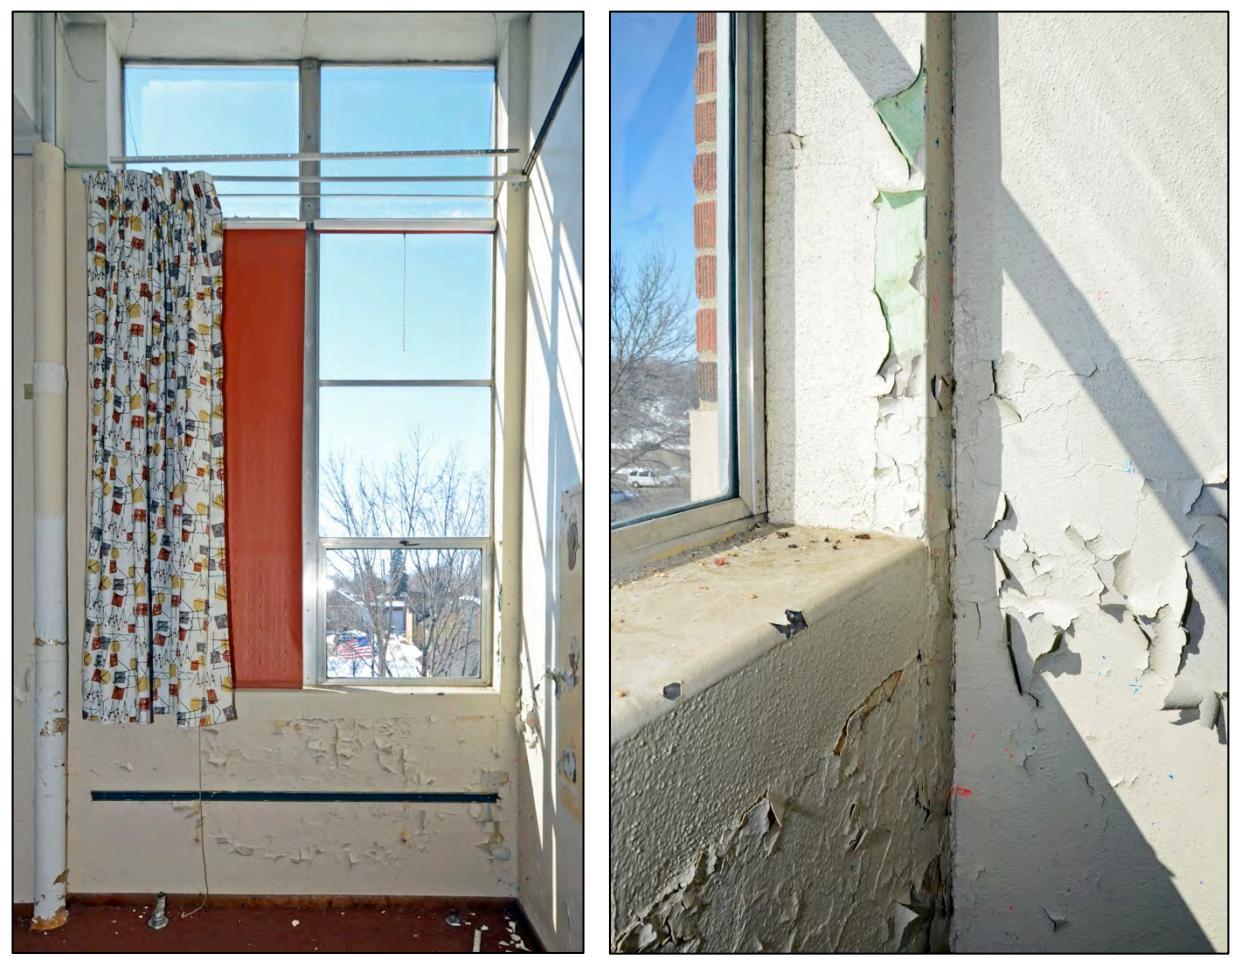
Photos 98-99. A window unit in room 304 (left). Single-glazed aluminum framed windows with hopper-type ventilators were installed throughout the building to replace the original wood double-hung windows. Detail at right shows construction of the window, configuration of the sill, and paint damage typical of that found beneath all of the upper level windows.
