Historic Properties Reuse Study of the Annandale Public School Annandale, MN

John Lauber and Company LLC Claybaugh Preservation Architecture Inc

October 2013

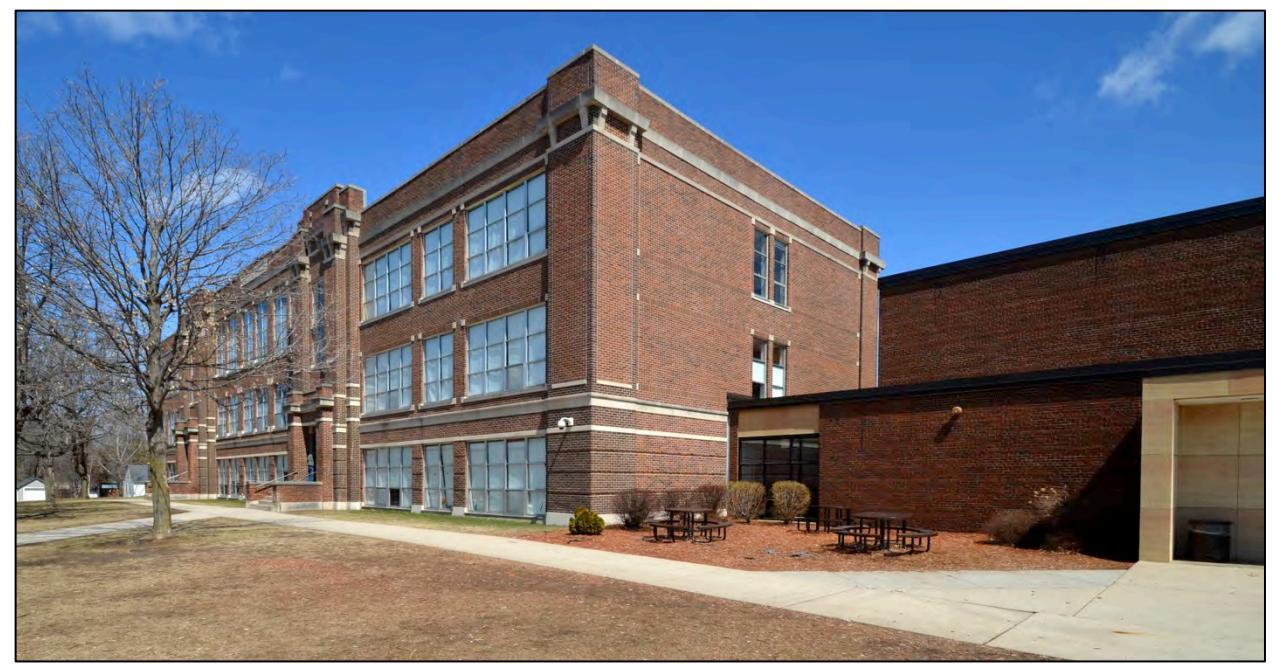
Photo 4. Looking northeast, showing the connection between the 1922 building and the 1954 addition. The main entrance to the complex is in the 1954 section.

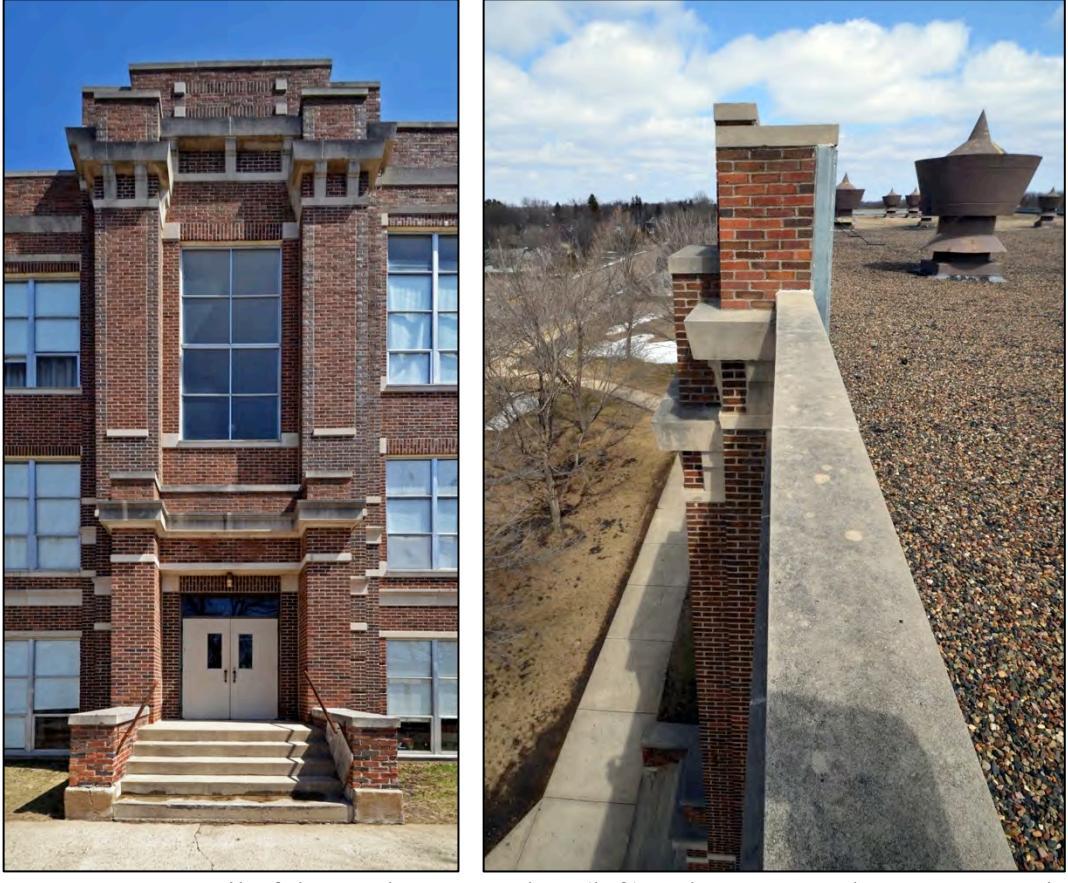
Photos 5-6. Detail of the north entrance bay (left). The entrance doors are not original. Profile of stone and brick detailing in the entrance bay as seen from the parapet (right).

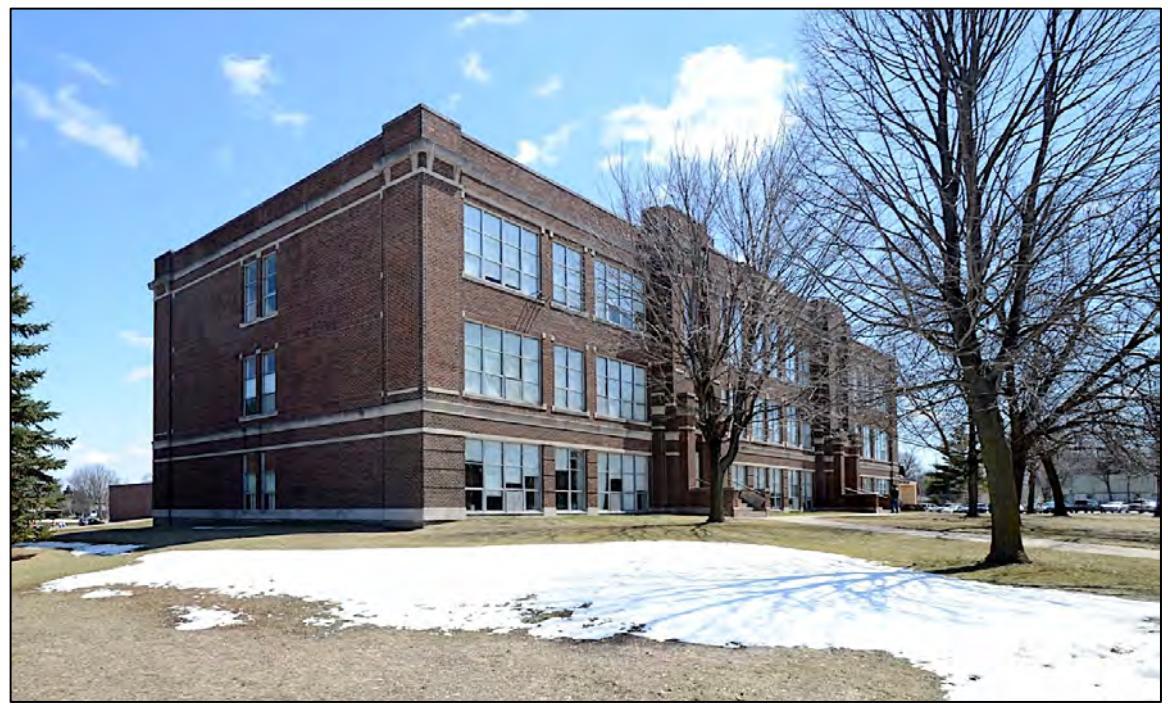
Photo 7. Looking southeast toward the west and north elevations.

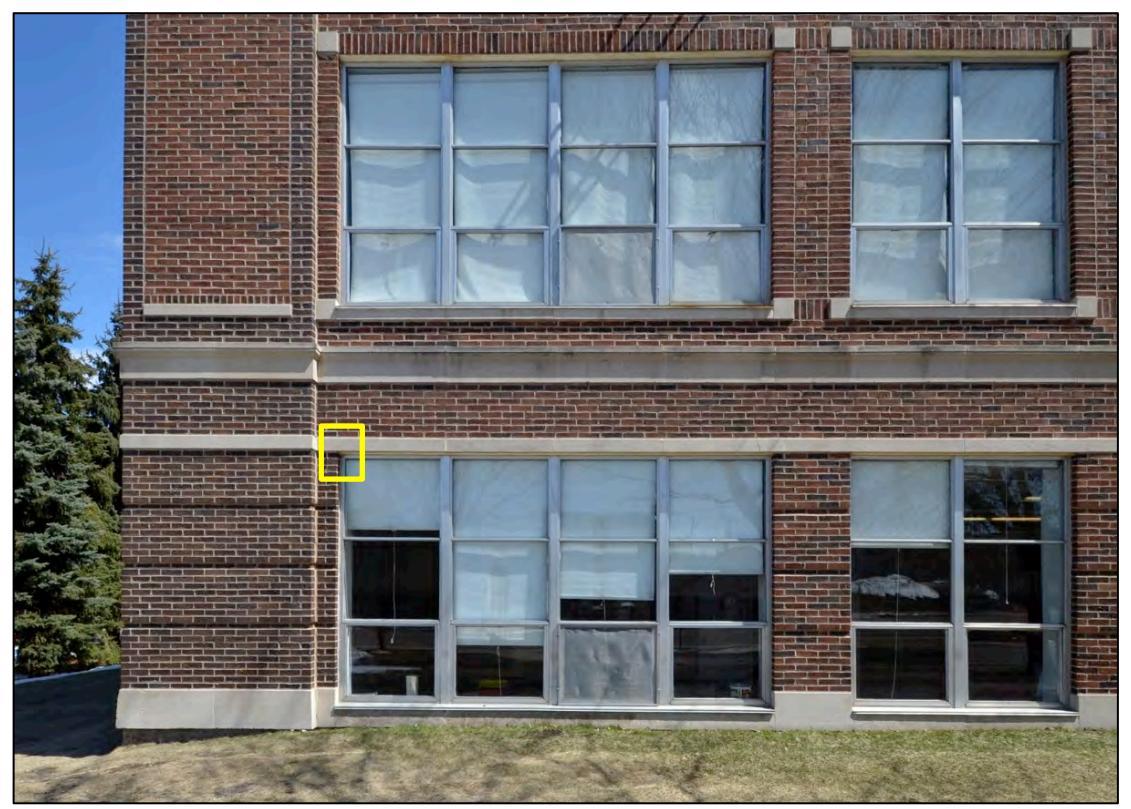
Photo 8. Detail of windows at the north end of the principal façade. The lower level is partially below grade. Note the limestone stone water table, string and belt courses, and corner medallions. Also note the ornamental brickwork, including the rusticated base, window frames, and panel in the corner pilaster. See photo 13 for detail of highlighted area.

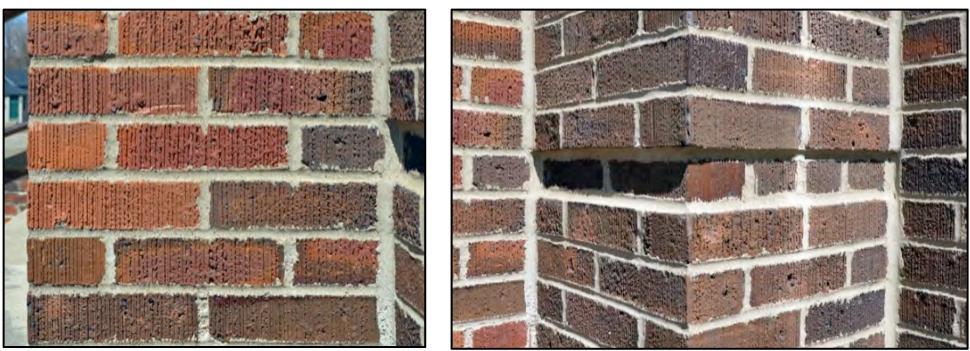
Photos 14-15. Variegated, wire cut face brick was used on the exterior of the building (left). Brick in the rusticated base is slightly darker in color (right). Mortar joints have been repointed, and are in exceptionally good condition.

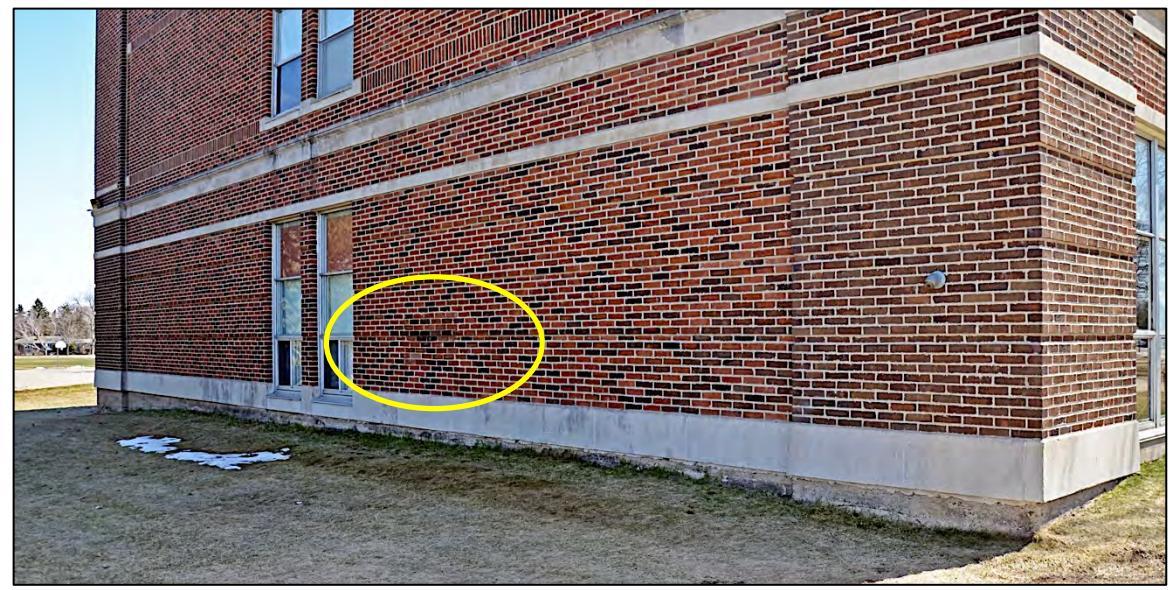
Photo 23. Close up view of north wall, showing area that apparently supported a plaque or sign.

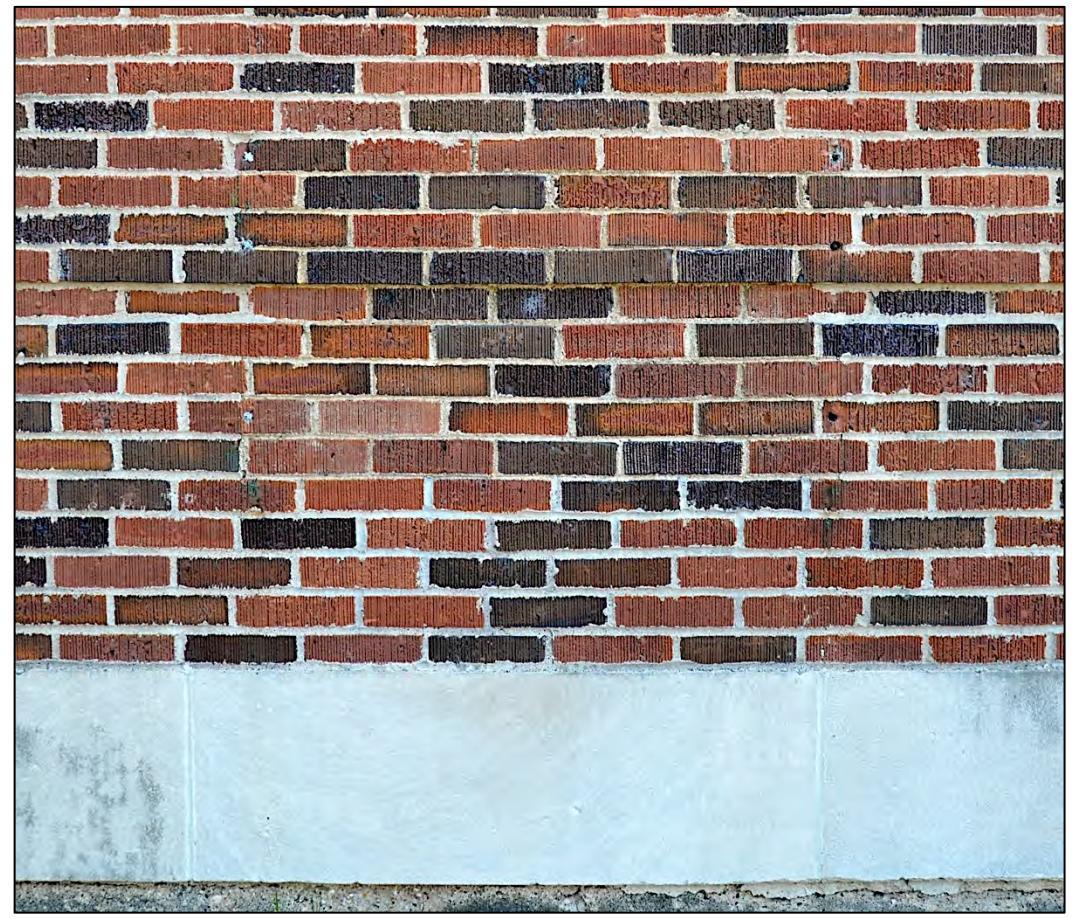
Photo 24. Anchors and green stains suggest that a bronze plaque may have been affixed to the wall in this location. Areas around the anchors have been repointed, leaving a "shadow" that indicates the size and shape of the plaque.

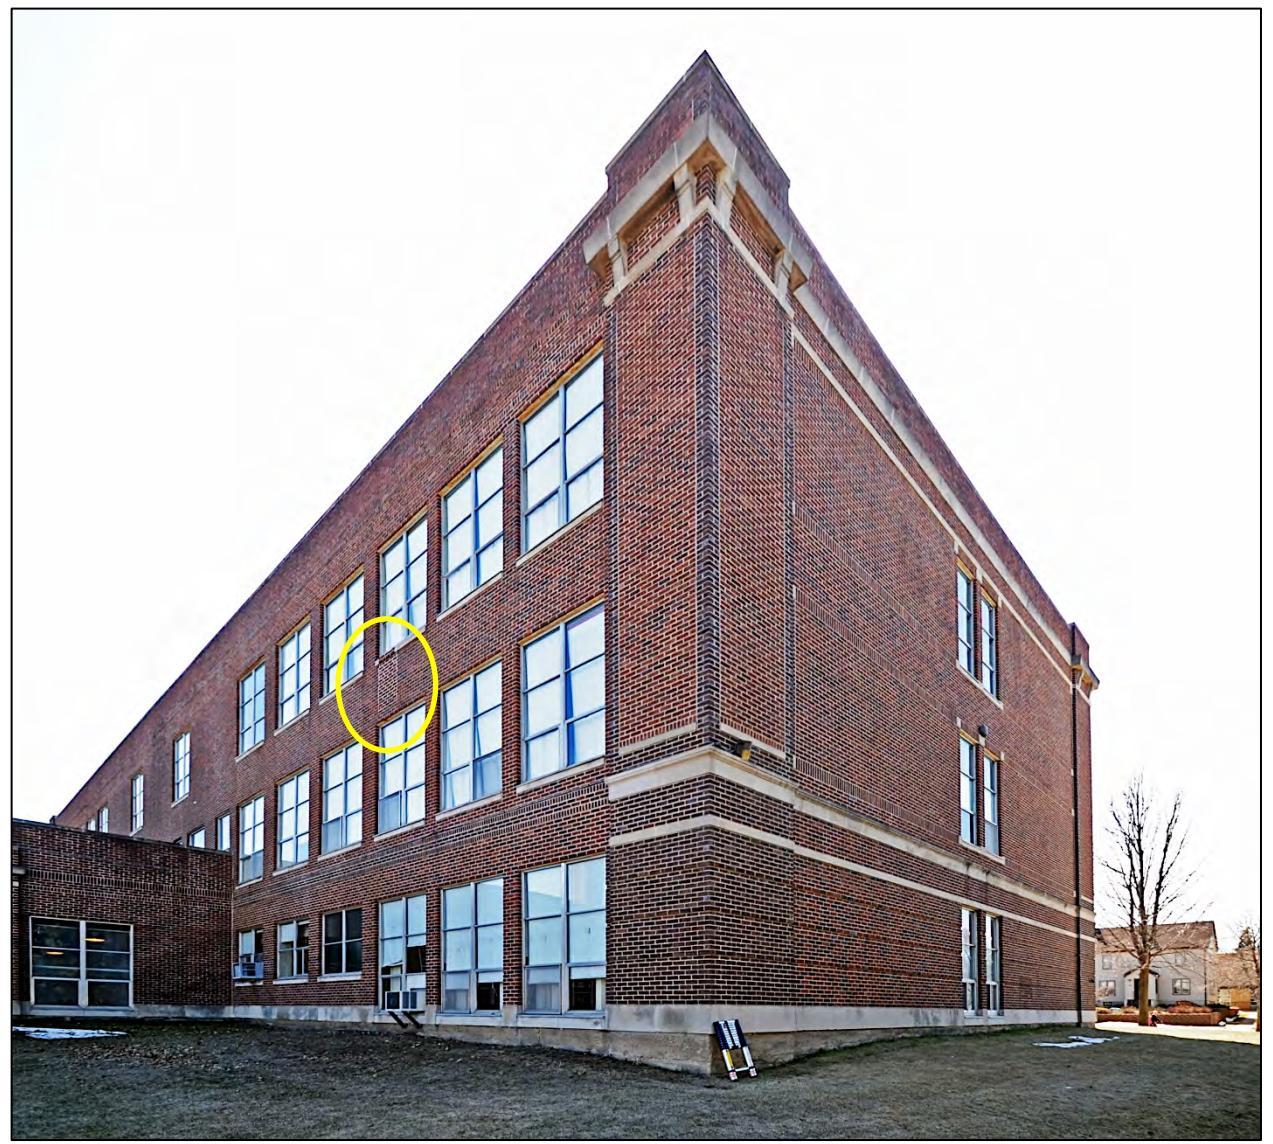
Photo 25. Northeast corner of the school building. Note two colors of brick used in in corner pilasters. Brick infill beneath windows may indicate former location of fire escape. There is a similar infill panel on the other side of the gymnasium wing.

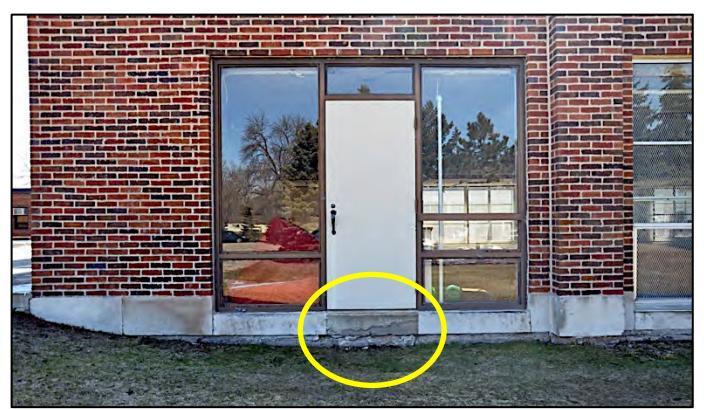
Photo 29. The east end of the gymnasium wing. The entrance door and glazing are not original.

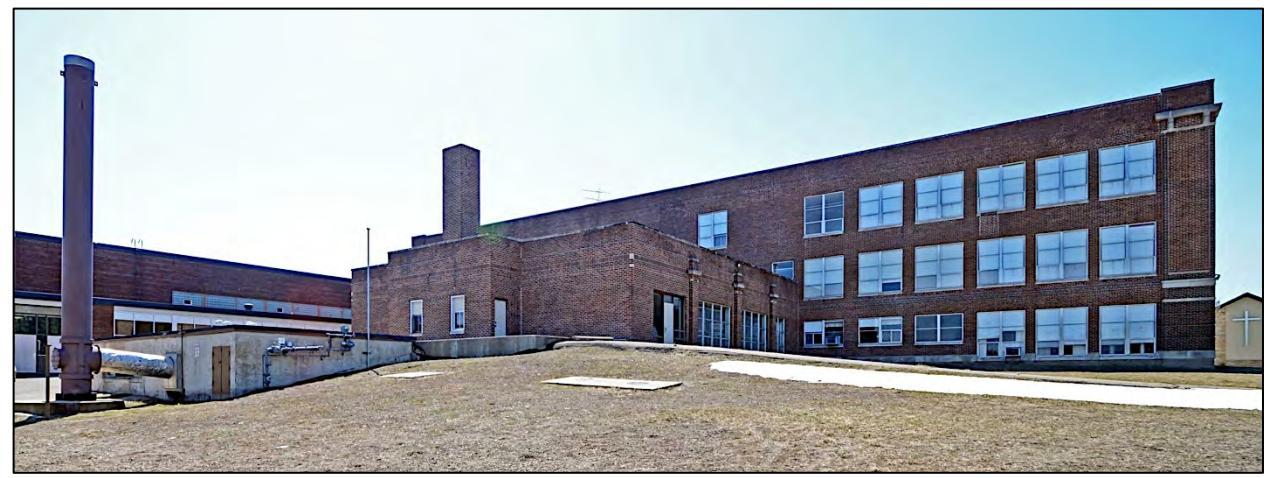
Photo 32. Looking southwest toward the back of the building. The low concrete structure extending beyond the gymnasium wing houses boiler equipment that was not part of the original building.

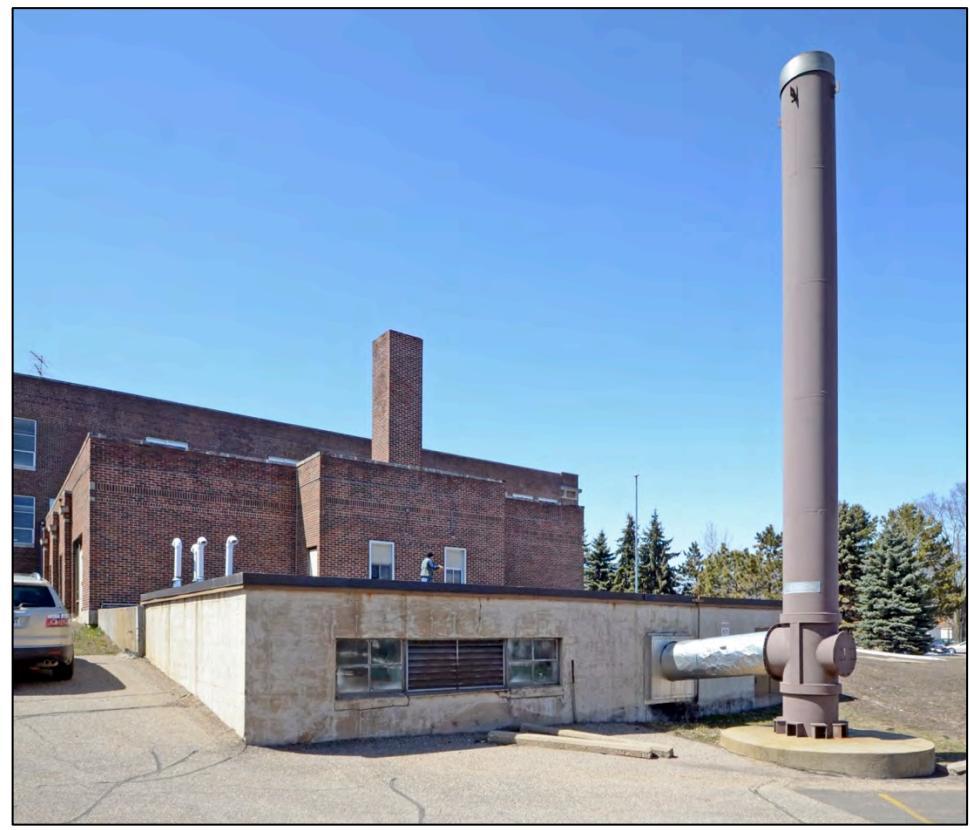
Photo 35. Looking east toward the boiler room. The concrete structure in the foreground was added to house larger boilers for the expanding complex and is not part of the original building

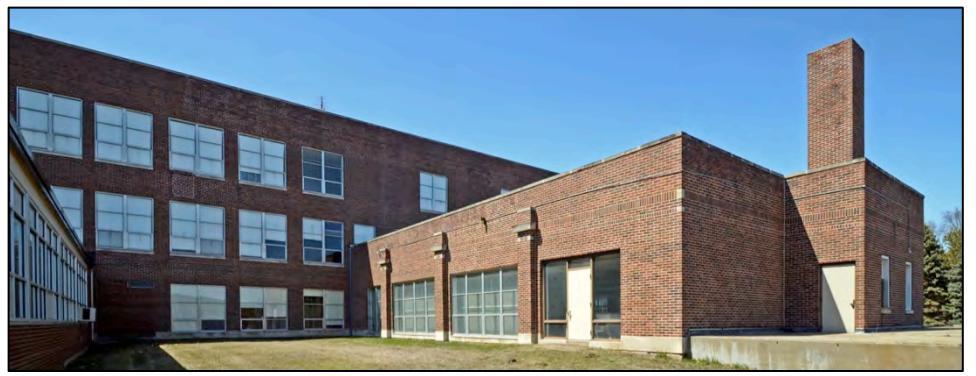
Photo 36. Looking northwest toward the back of the building. The upper portion of the original chimney has been removed.

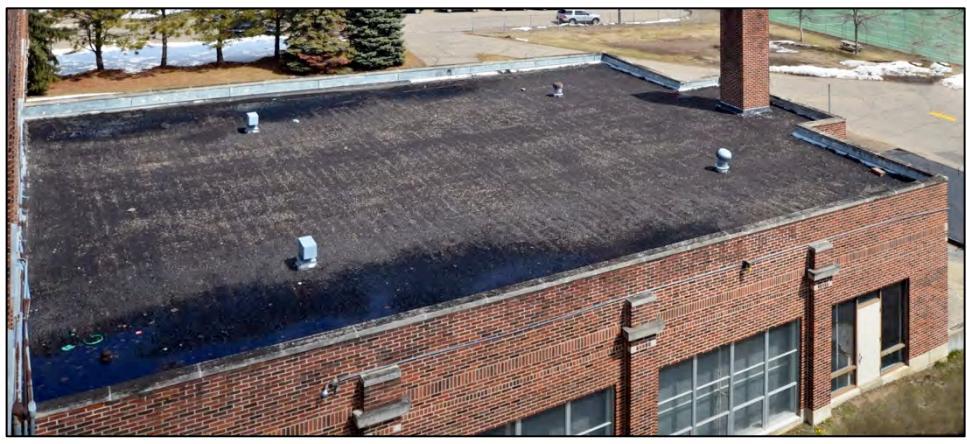
Photo 37. View of the gym roof, looking northeast. Note standing water along the parapet.

- Flat roof sloped to two interior roof drains.
- Tar and gravel roofing over wood sheathing and joists that we were told dates from the late 1950s. The roof surface is bubbled and cracked in many areas but is still performing. There is evidence of previous roof leaks adjacent to the north roof drain.
- The roofing turns up the parapet wall with a beveled cant strip and terminates about 8" above the roof.
- The parapet is capped with 10" x 5" stone coping.
- The back of the parapet is covered with heavy gauge galvanized sheet metal let into the coping stone bed joint and extending to just

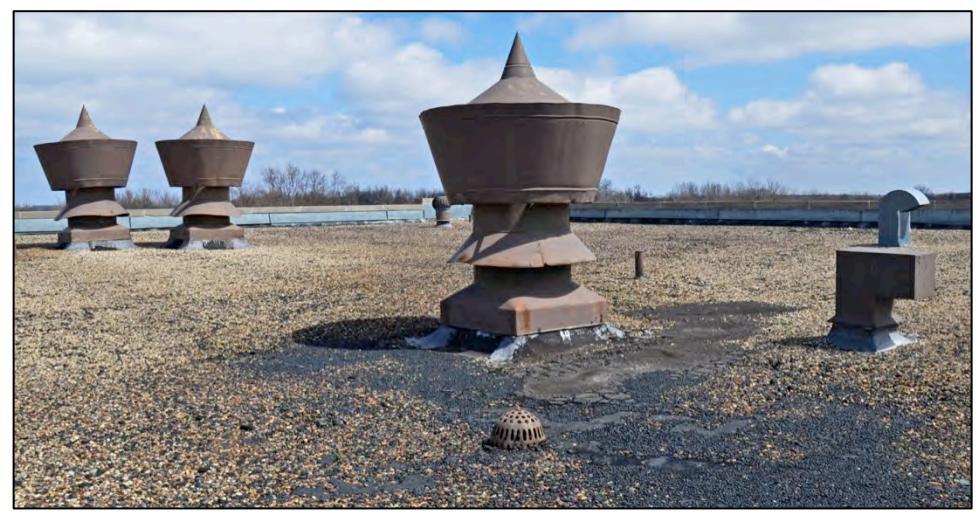
Photo 41. The roof is reputed to date from the late 1950s, and has functioned remarkably well, although some areas, such as this section adjacent to a drain are badly eroded.

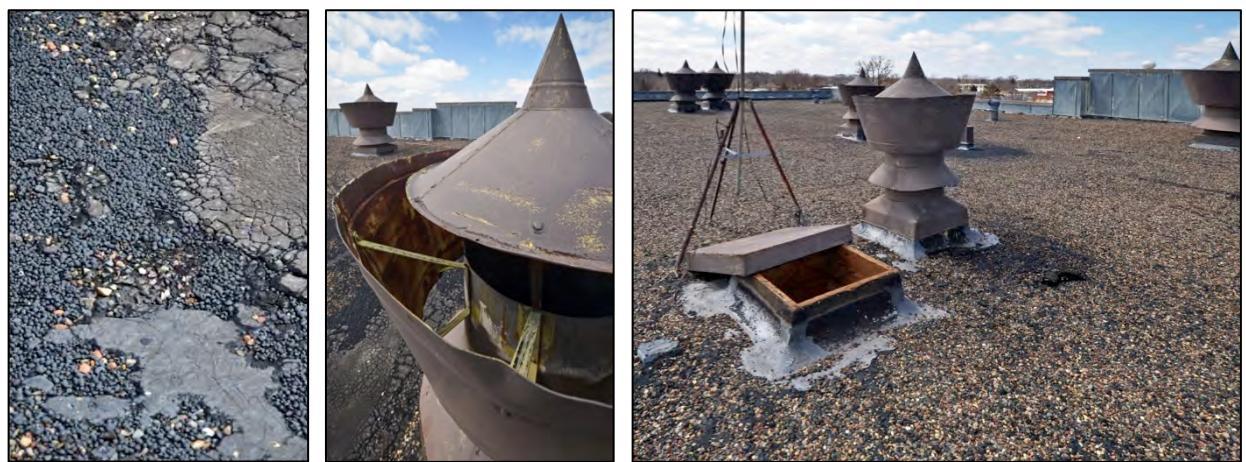
Photos 42-44. Detail of pitch and gravel surface (left). Roof ventilators are part of the original air circulation system, which remains in use (center). There is some evidence of water infilatration through the ventilators. A wooden hatch sheathed with sheet metal provides access to the roof from the attic (right).

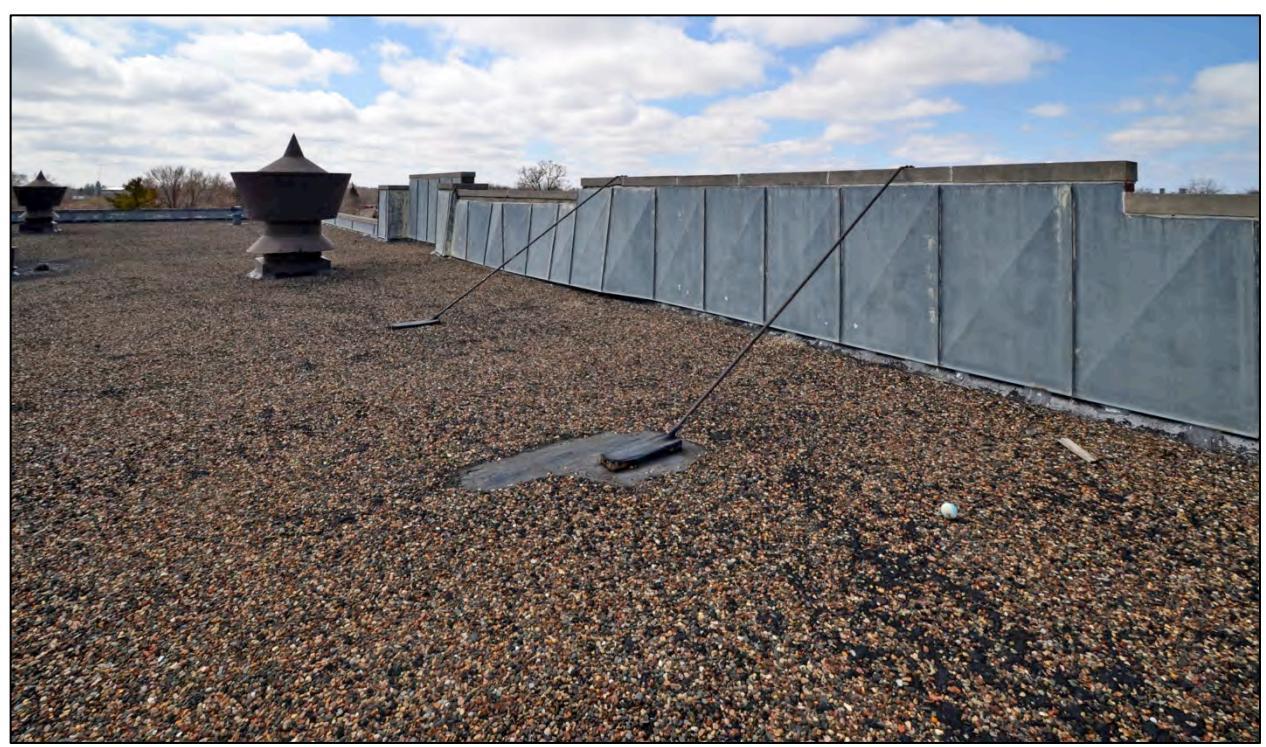
Photo 46. Full-height sheet metal counter flashing is installed on the backsides of the parapets. Iron rods help to stabilize the parapet above the main entrance.

- The sheet metal is generally in very good condition except where it has come loose at the high parapets in the center of the west façade.
- The sheet metal covers a soft brick so the sheet metal was mostly likely part of the original construction.
- Main roof penetrations include:
 - Original large roof ventilators on wood curbs.
 - Newer turbine ventilators that extend straight through the roof.
 - Goose neck vents probably to ventilate the restrooms.
 - Plumbing vents.
 - Wood roof hatch on a wood curb.
 - Gymnasium roof penetrations are only the two interior roof drains toward the west end and the brick chimney.

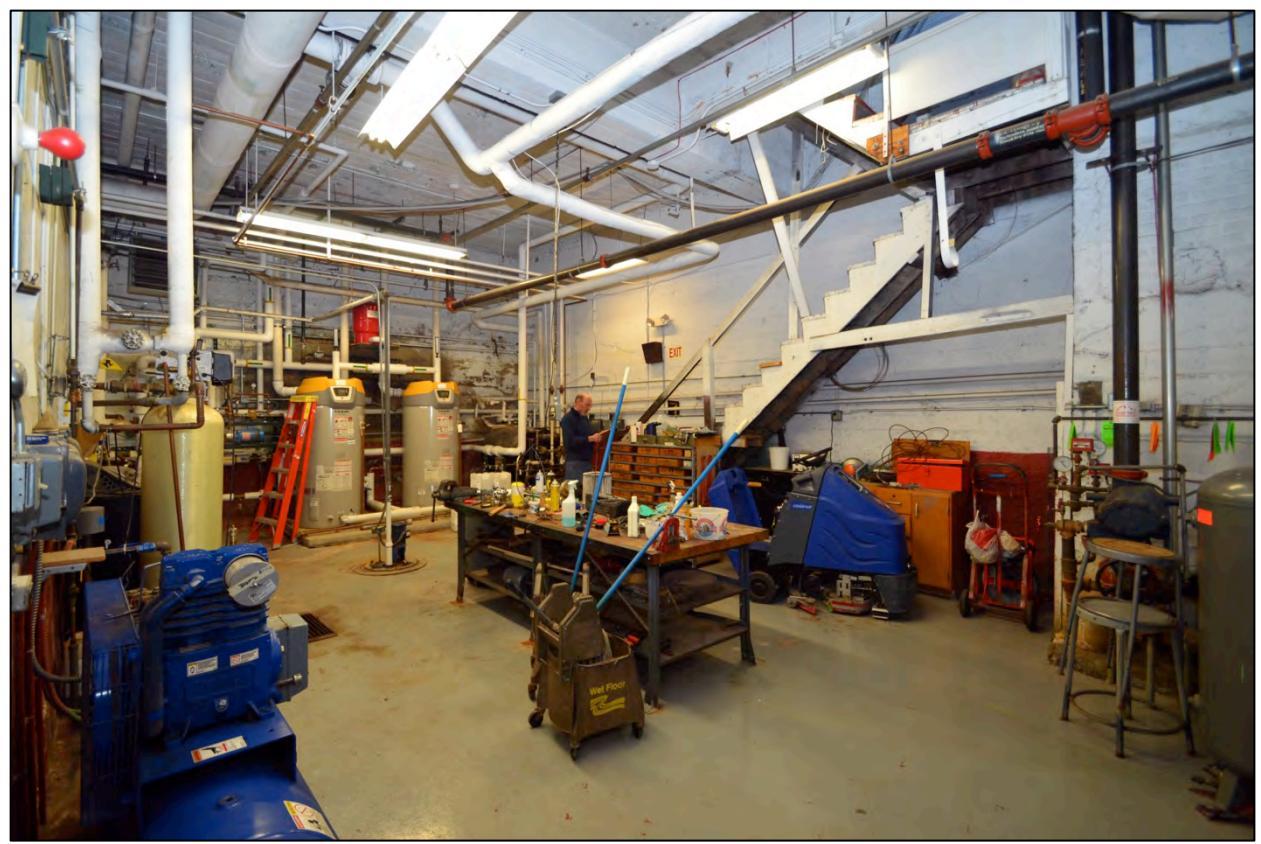
Photo 53. Looking across the original boiler room. The original chimney stack is visible at right, and water heaters are visible in the background at left.

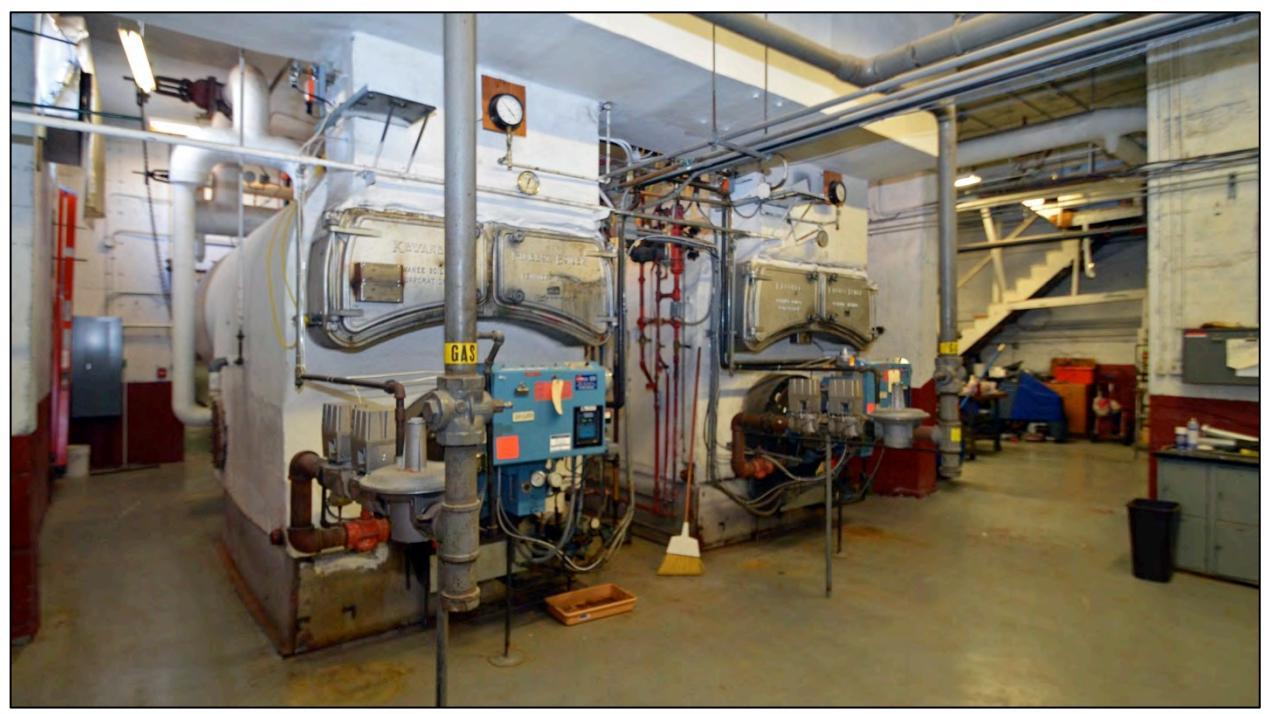
Photo 54. Two large, aging Kewaunee boilers in the newer boiler room generate steam to heat the entire school complex.

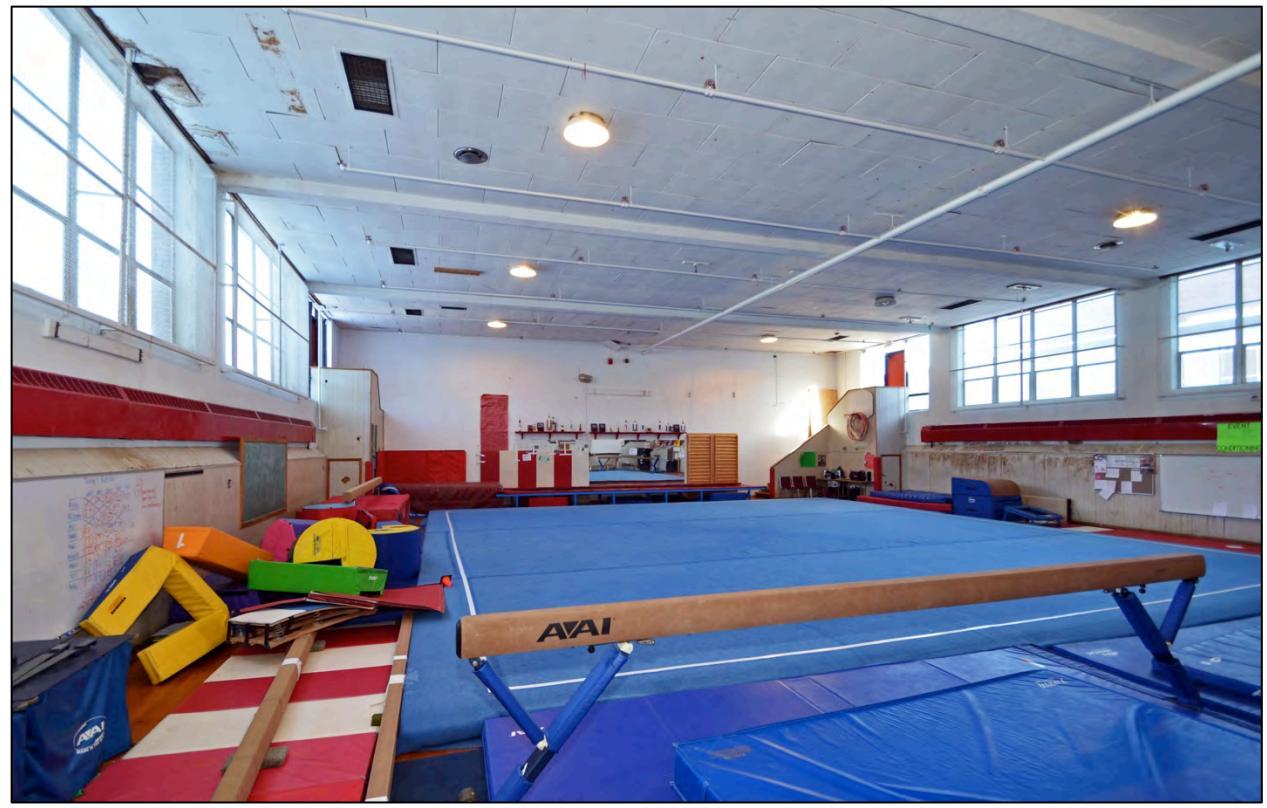
Photo 59. Looking across the gymnasium toward the southeast. Staircases adjacent to the windows on each side open to the exterior.

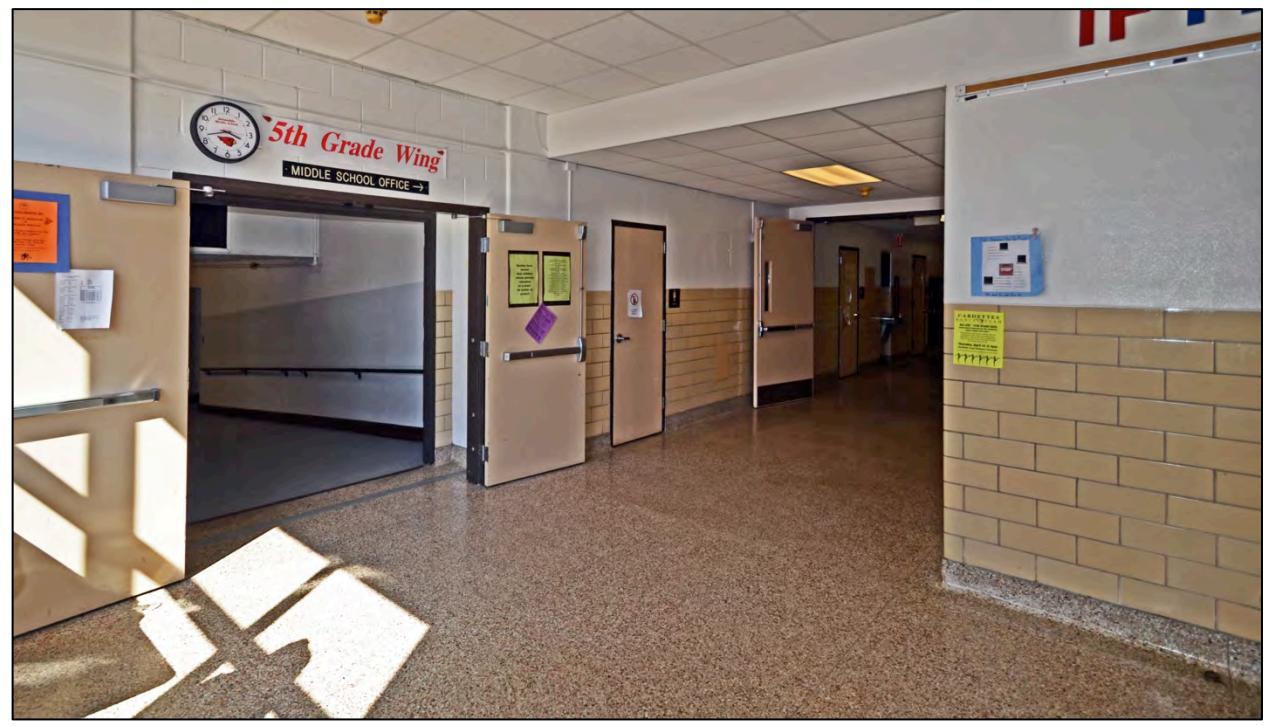
Photo 64. Junction between 1922 building (through doorway at left) and 1954 addition. Restrooms for main floor are located at this intersection in the original building.

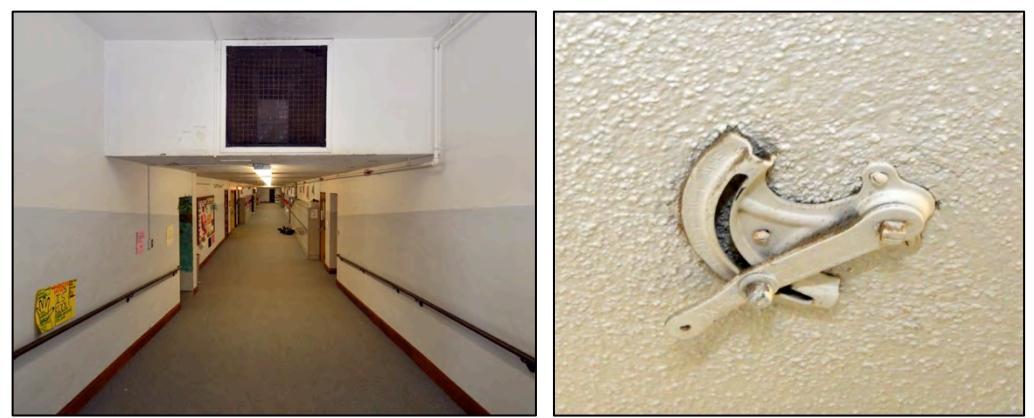
Photos 65-66. Looking down the main corridor on the lower level (left). The corridor is gently sloped to adjust for differing floor levels between the original and newer sections of the complex. A plenum above the corridor is part of the ventilation system. A series of dampers in the plenum (detail right) allows building engineers to adjust airflow to rooms throughout the building.

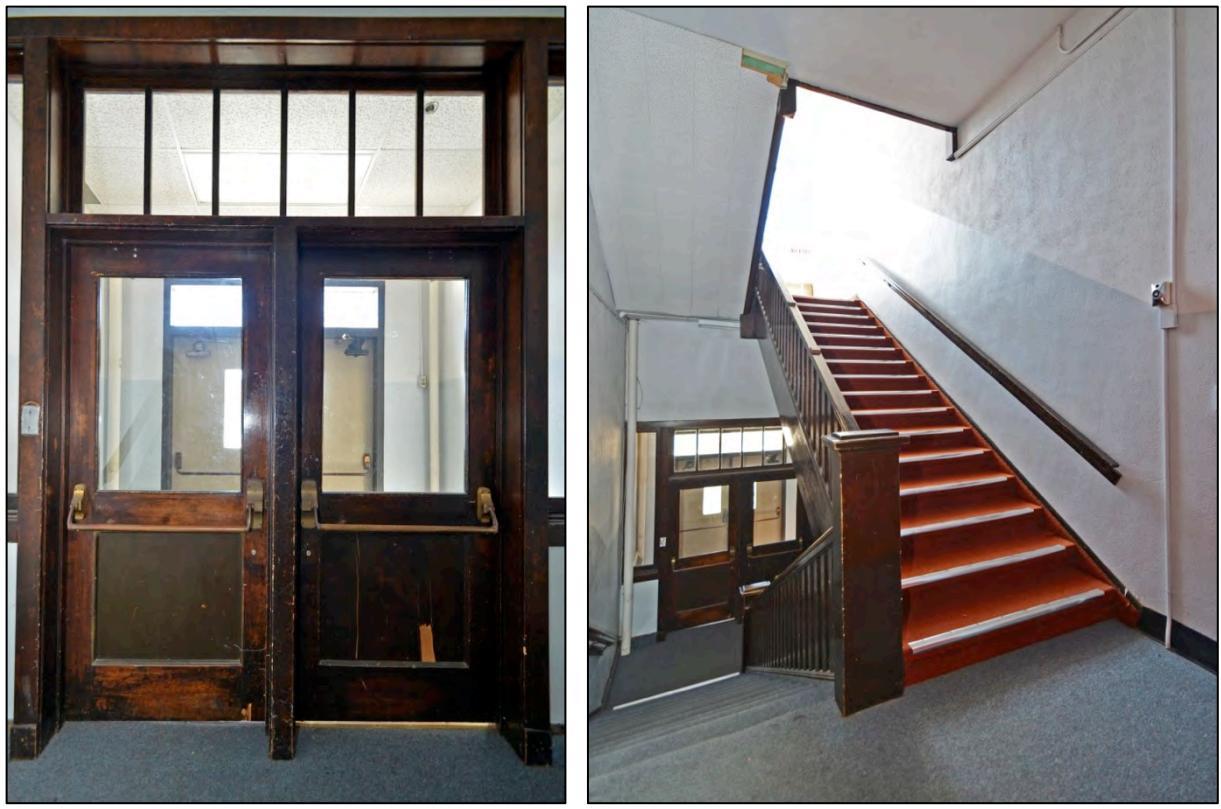
Photos 74-75. The original double entrance doors, transom, and sidelights remain in place. The original exterior doors have been replaced with steel flush doors (left). Original newels and balustrades remain in place in the main stairways.

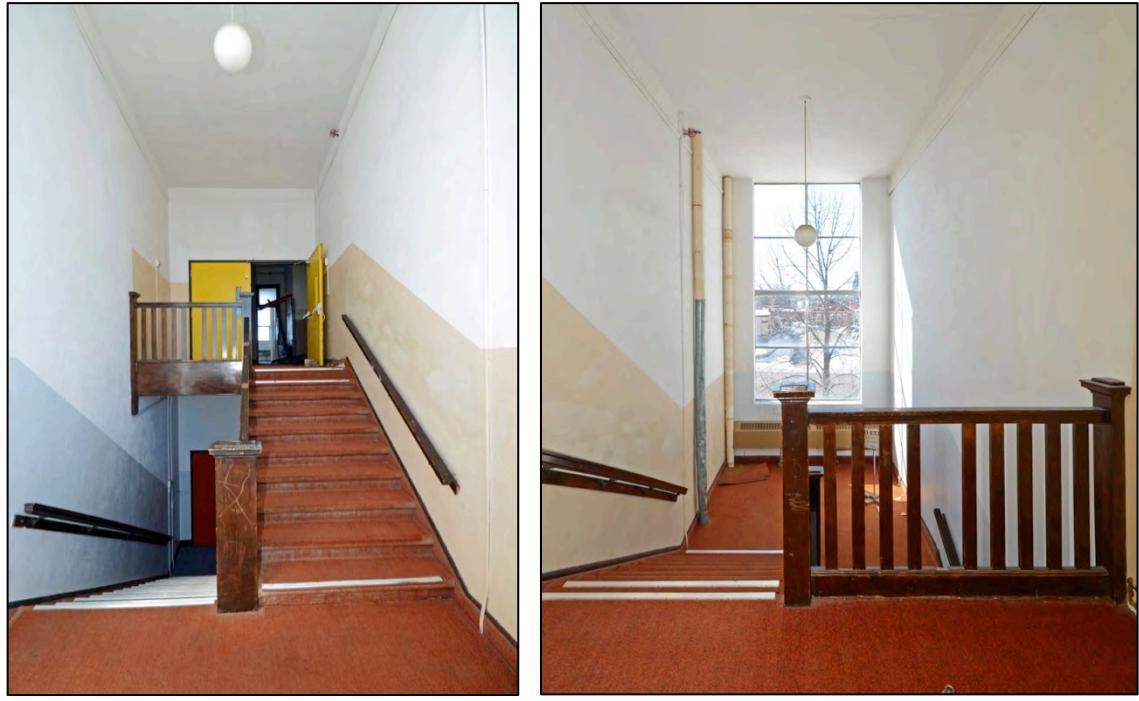
Photos 76-77. Steel flush doors have been installed in the stairwells at each level as a fire safety measure (left). Large windows admit ample light to the stairwells (right).

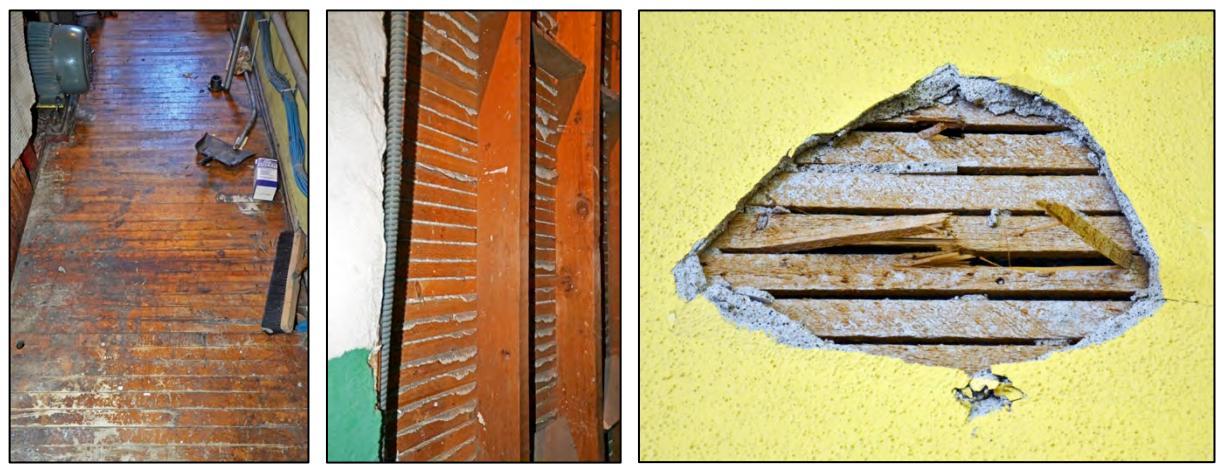
Photos 80-81. Floors were originally surfaced with tongue-and-groove maple (left); walls were finished with sand-float plaster applied to wood lath or key tile (center and right).

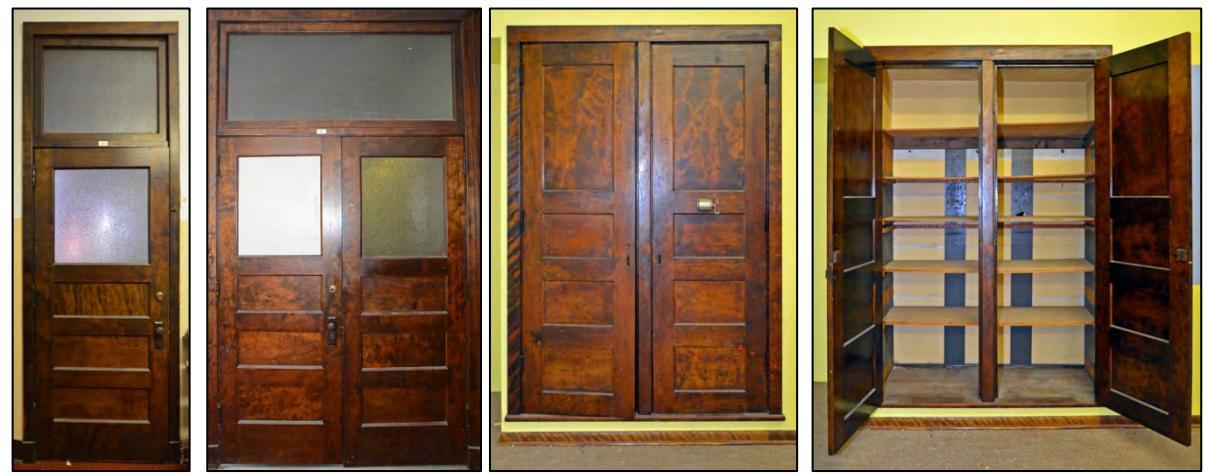
Photos 82--85. The original frame-and-panel doors and transoms remain in place throughout the building. The stained and varnished birch doors are in good condition.

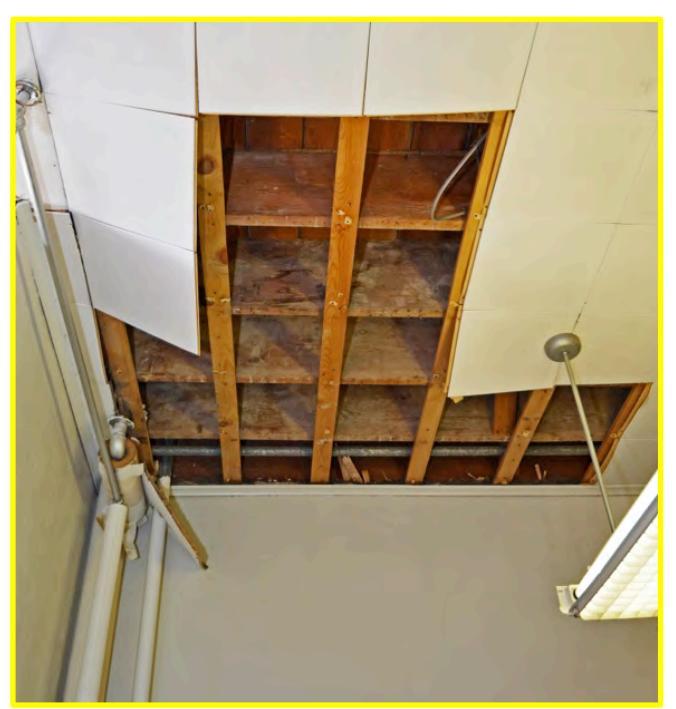
Photo 90. Detail of the circled area in Photo 92. Celotex ceiling tiles in one corner of room 205-206 have been removed, exposing the building's wood-framed floor system.

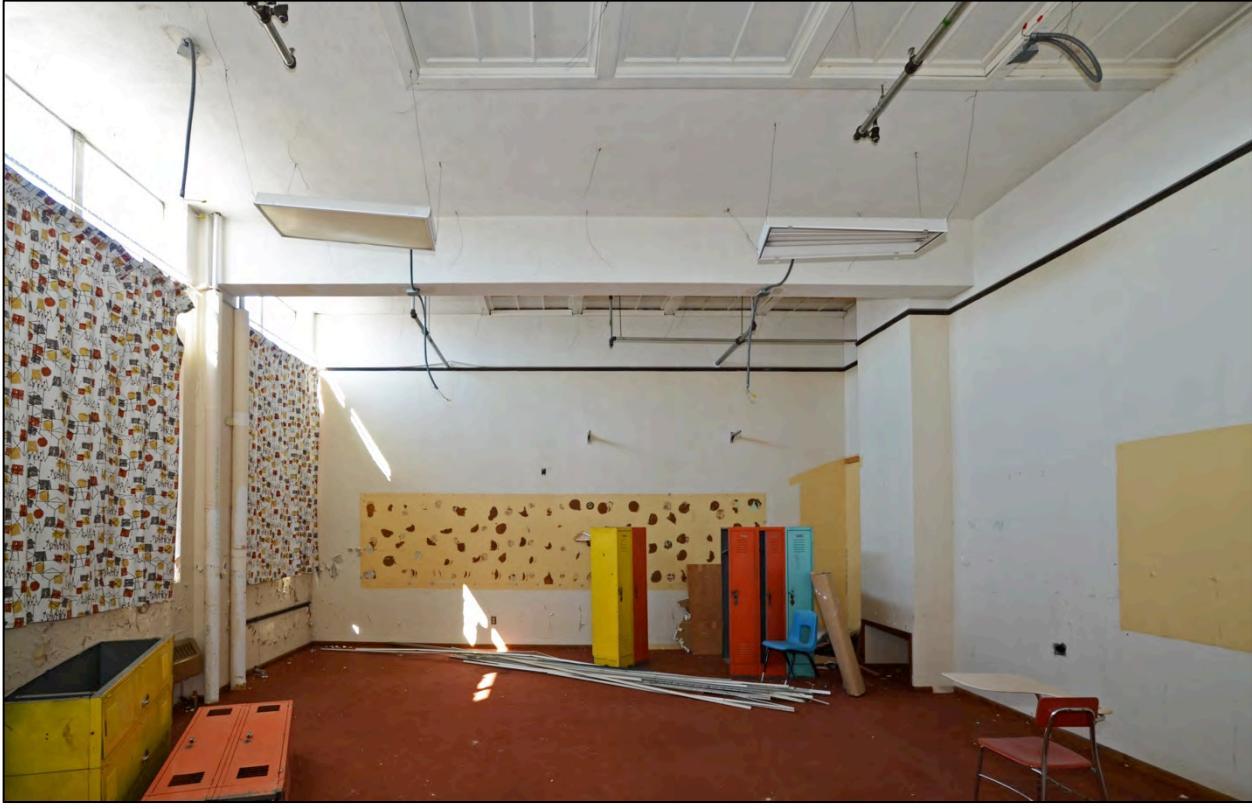
Photo 95. Room 304 was originally part of a large, skylit study hall on the upper level. Steel beams in the ceiling allowed the room to be free of columns. The room was later partitioned into a series of smaller spaces, but the skylight framing remains visible here and in the corridor.

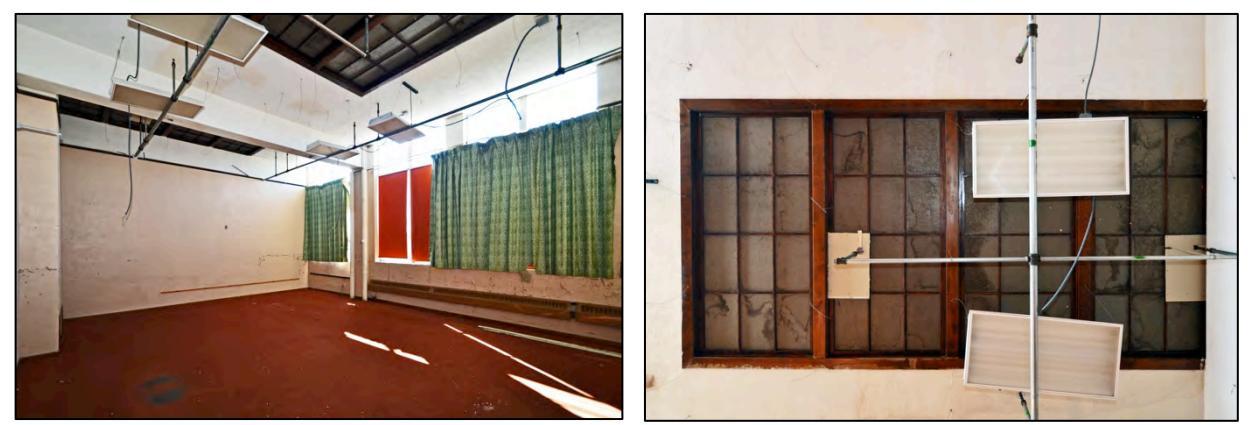
Photos 100-101. Room 305 was also originally part of the study hall (left). Curtains here and in many other rooms are drawn to reduce heat loss through the single-glazed, aluminum-framed replacement windows. The skylights in this room retain their original finishes. They were hidden for many years above a suspended ceiling system.
