Historic Properties Reuse Study of the Annandale Public School Annandale, MN

John Lauber and Company LLC Claybaugh Preservation Architecture Inc

October 2013

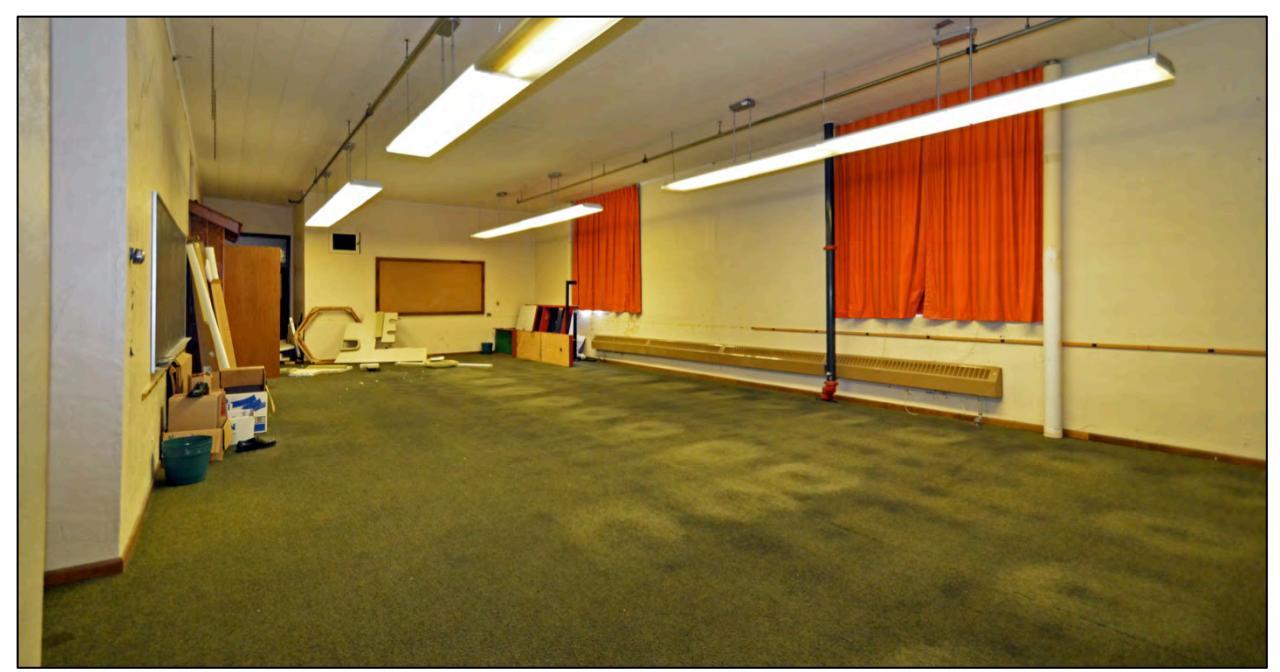
Photo 102. Situated directly across from the original study hall, room 312 was originally partitioned into separate coat rooms for boys and girls. The main corridor on this level passed through the space on the left side of the photo.

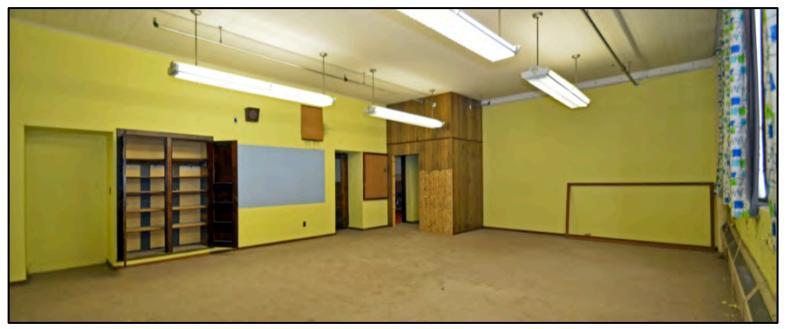
Photo 103. Although little evidence of its original purpose remains today, room 307 was initially used as a science laboratory for the high school.

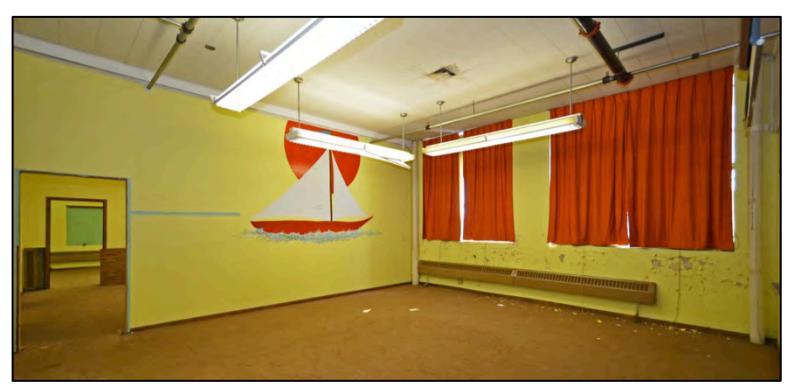
Photo 104. Now subdivided into a series of connected class spaces, room 308 originally housed Annandale's normal school program, where high school students once received the training they needed to teach in elementary and rural schools.

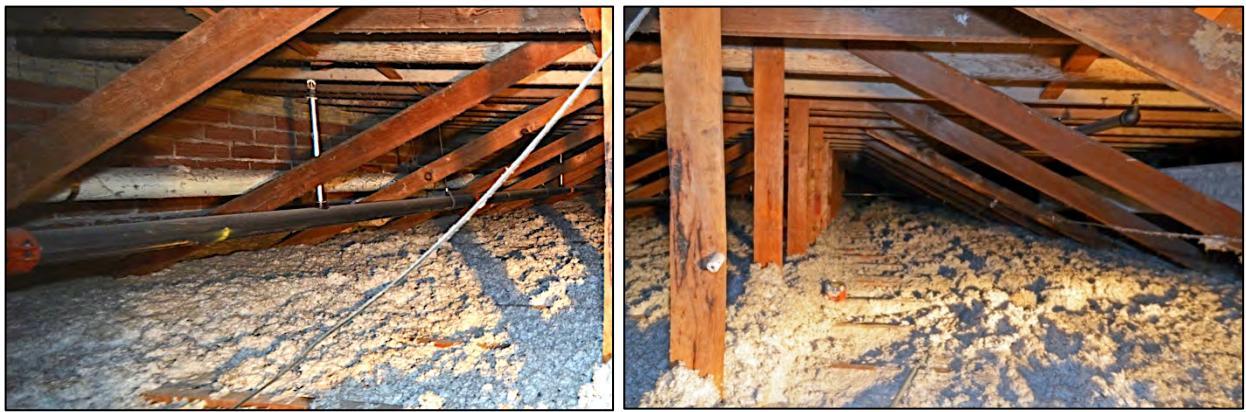
Photos 105-106. Roof framing is visible in the attic. The system is built entirely of wood, with the roof deck supported by a series of simple site-built trusses. The attic contains a thick layer of cellulose insulation.

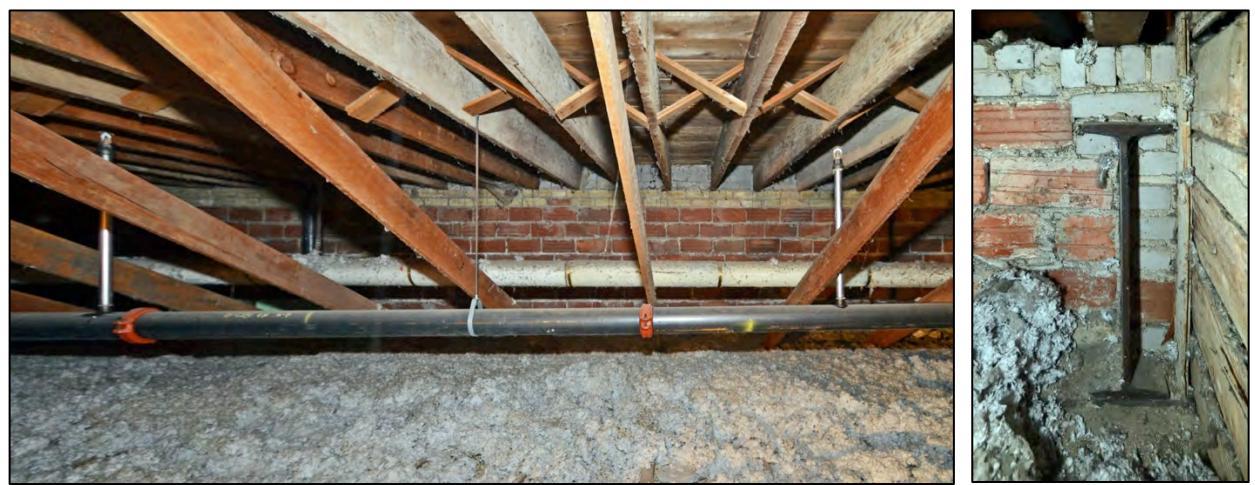
Photos 107-108. Joists for the roof deck rest on a tile ledger/inner wythe capped by brick. Spaces between the joists are filled with mortar (left). An I-beam carries the roof over the original study hall (right) making it possible to create an open space uninterrupted by columns.

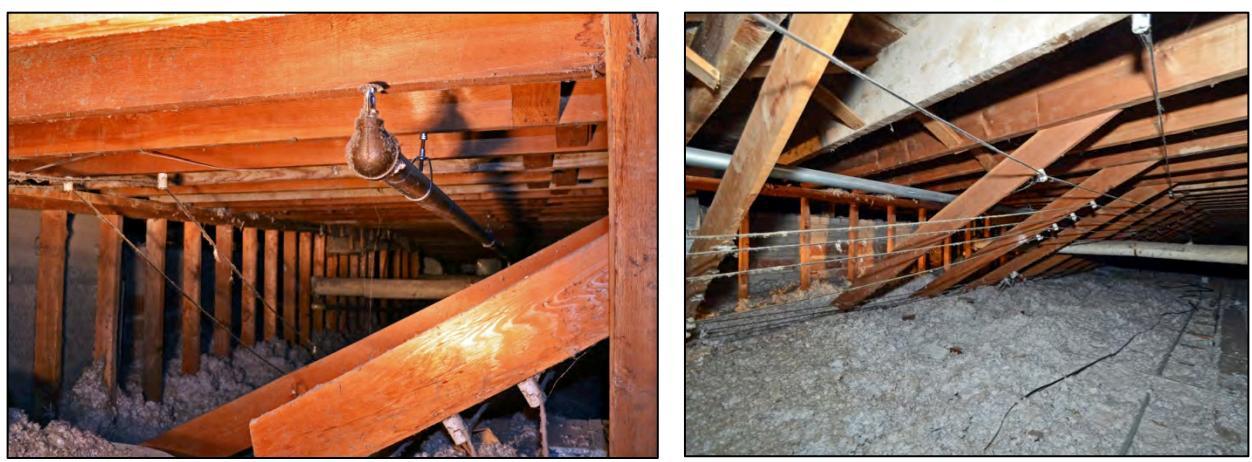
Photos 109-110. The building is fully sprinklered (left). Vestiges of the original knob-and-tube wiring remain in place (right), although active wiring is routed through metal conduit.
